MONITORING OF THE EFFECTIVENESS OF MITIGATION MEASURES IN SLOVENIA

Action D.2: Evaluation (monitoring) of the effectiveness of mitigation measures implemented to prevent traffic related bear mortality

Title of the project: **LIFE DINALP BEAR (LIFE13 NAT/SI/000550): Population level management and conservation of brown bears in northern Dinaric Mountains and the Alps**

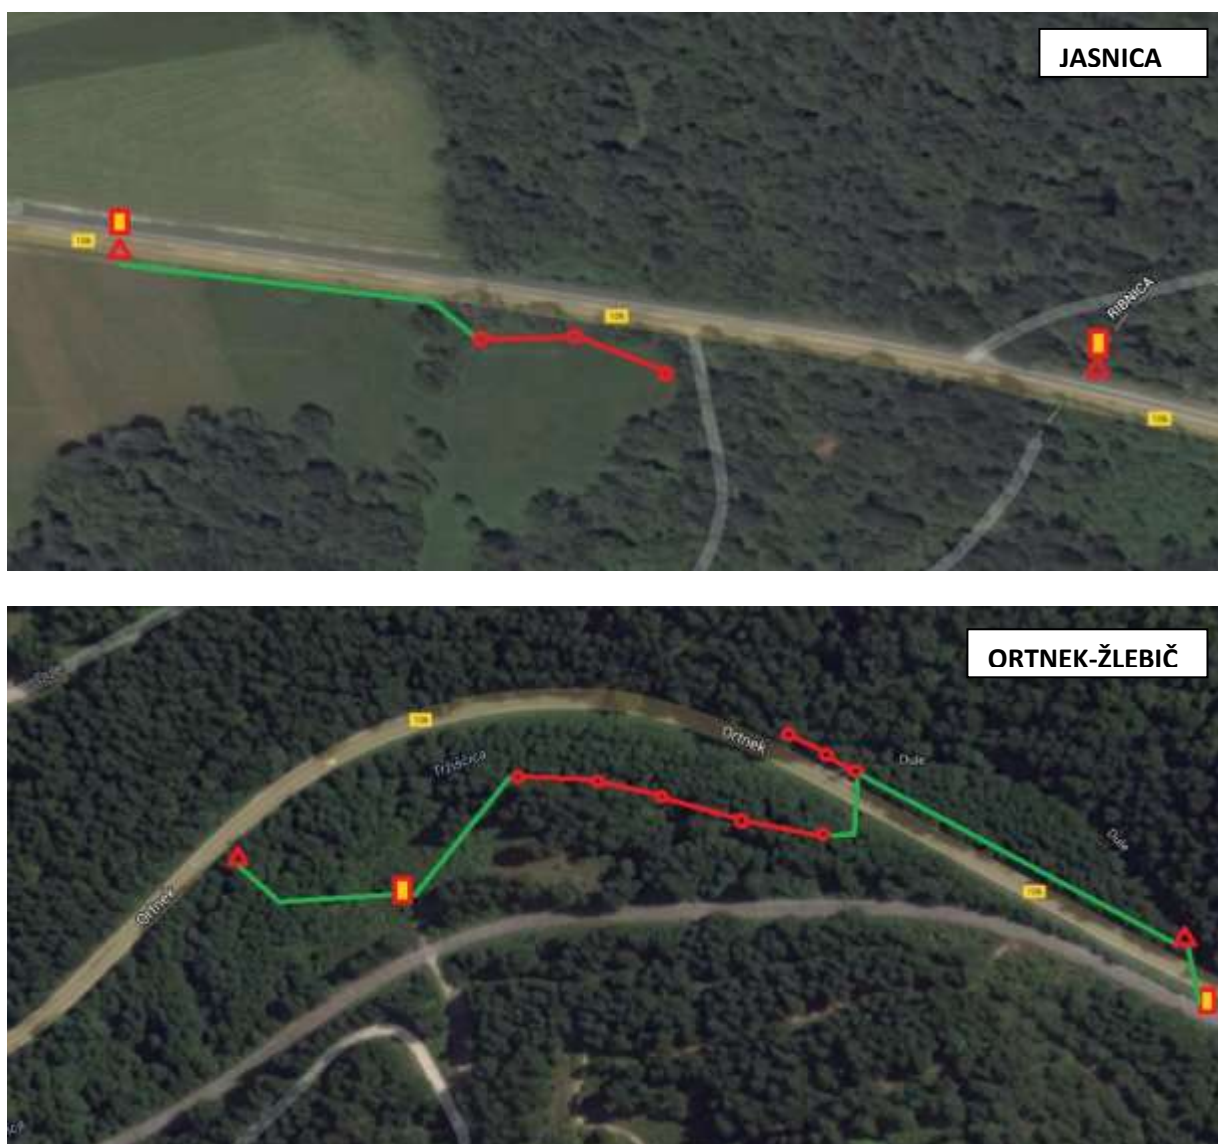
Figure 2: Dynamic traffic signs; sensors (red line), power lines (green line), solar cells (yellow rectangle) and traffic signs (triangle). Above: Jasnica; below: Ortnek.

At the end of the year 2015, two systems of dynamic traffic signs were placed along two sections of the main road Ljubljana – Kočevje (between Zgornje Lozine and Dolenja vas (Jasnica) and between Ortnek and Žlebič) to alert and slow down drivers in order to avoid potential collisions with wildlife, including bears. Dynamic signs were coupled to sensors capable to detect large animals approaching to the roadways (see Figure 2). In the case of approaching bear (or ungulates), the signs light on and send the message to the driver that an animal is approaching the road. Since the sensors are not bear-specific, they provide also higher road-safety considering collisions with other large mammals, particularly ungulates.

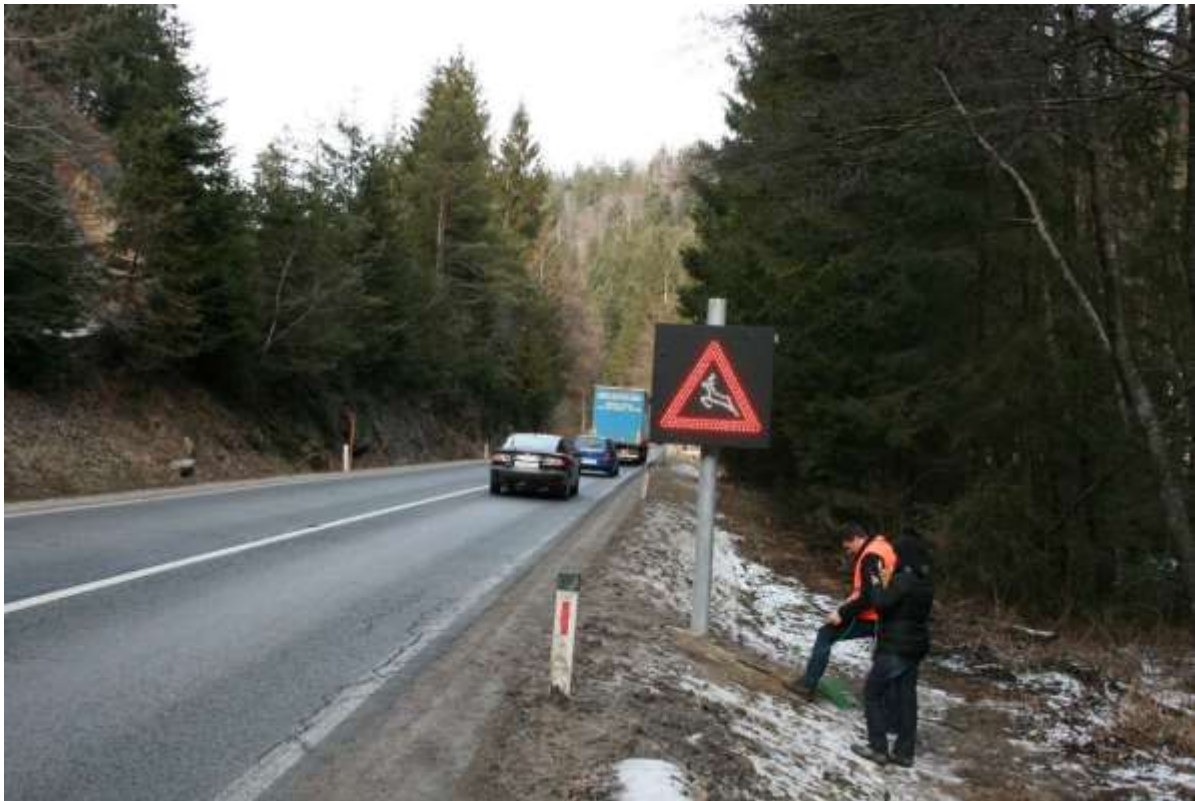
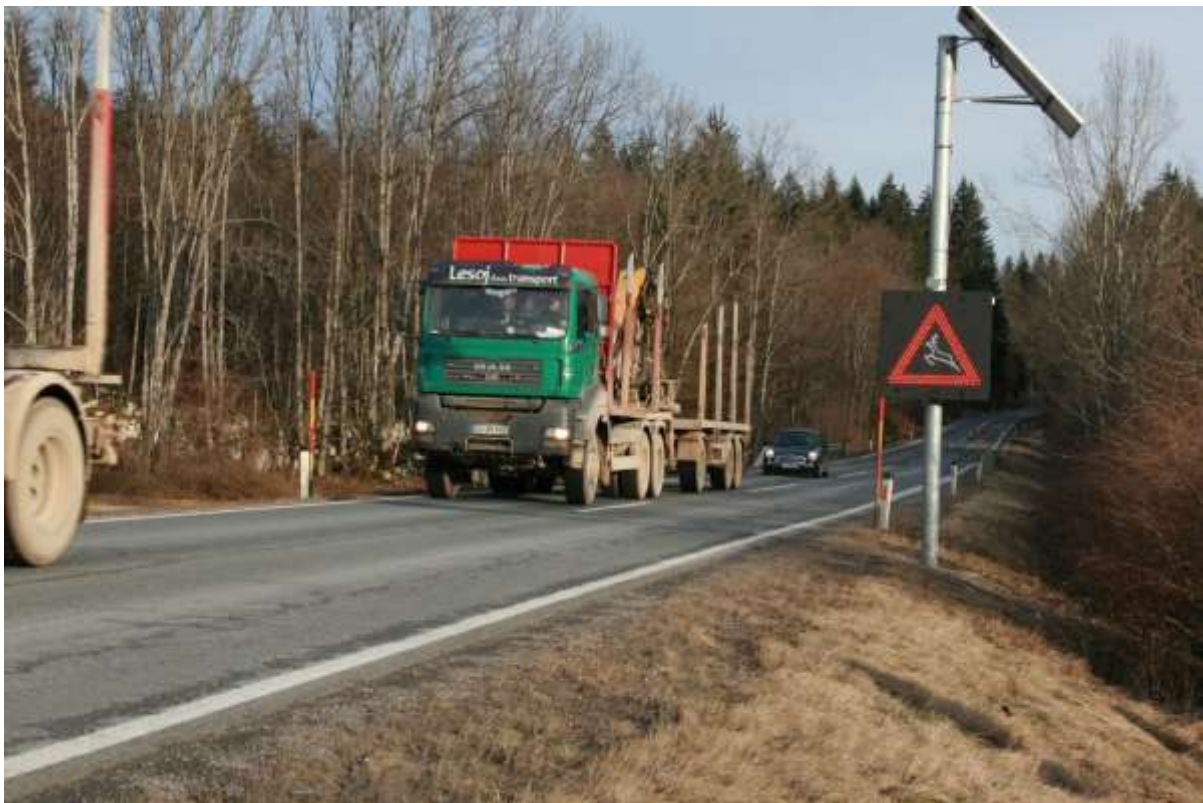
Figure 3: Dynamic traffic signs placed along two sections of the main road Ljubljana – Kočevje (above: Ortnek; below: Jasnica) (photo: Z. Pavšek, 2016).

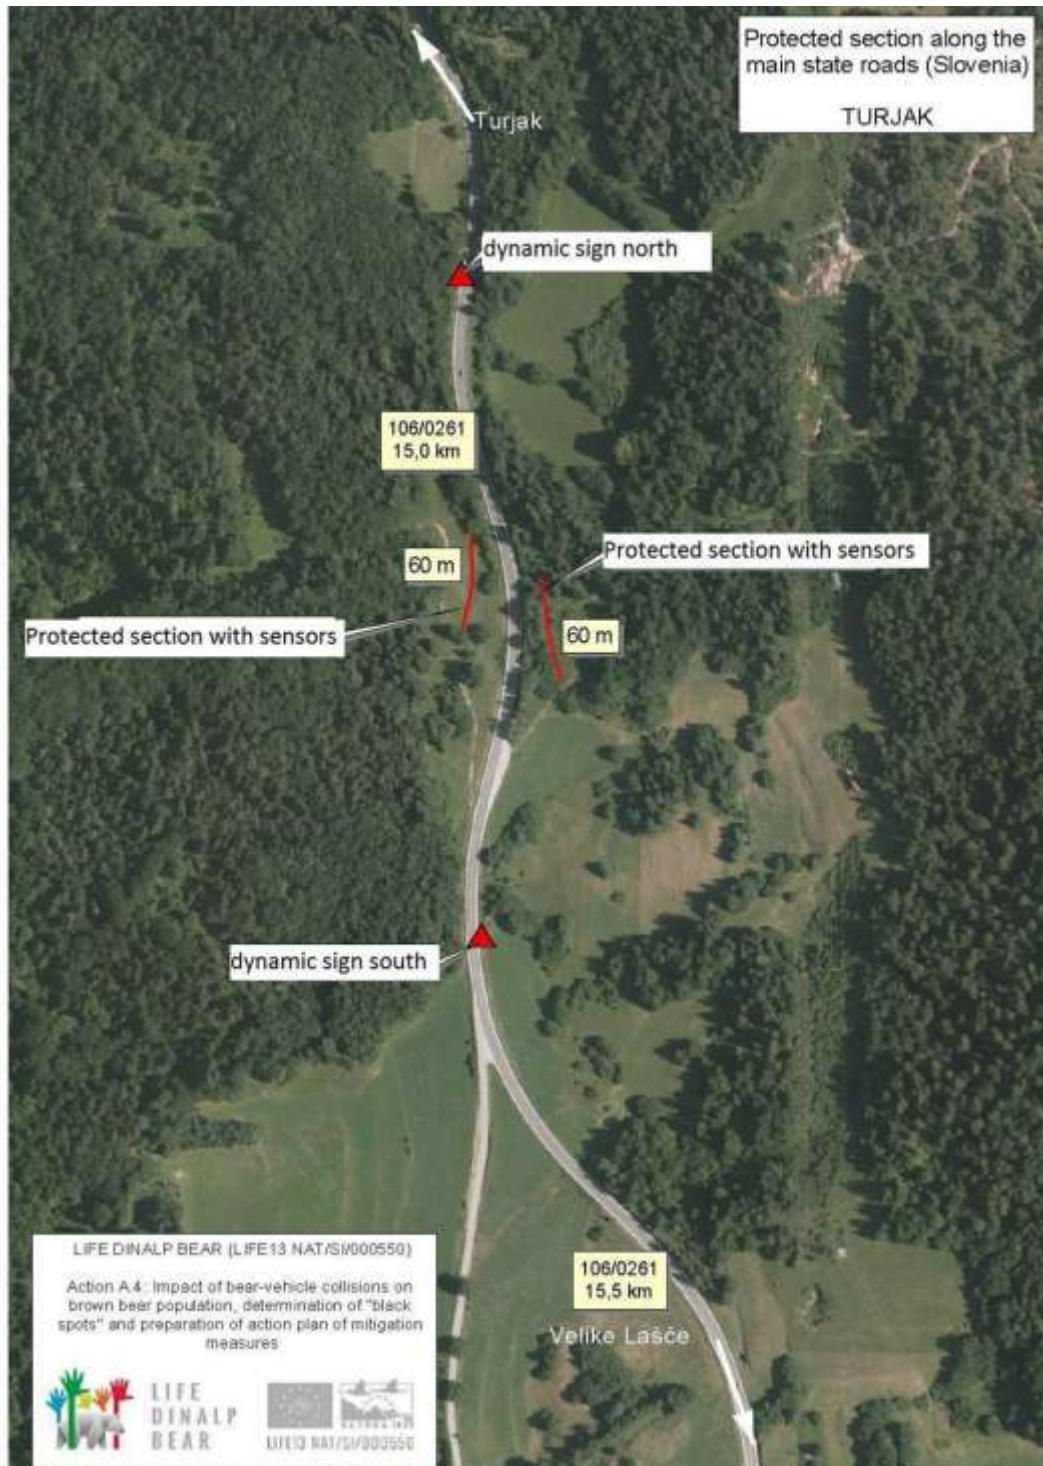
Figure 4: Dynamic traffic sign at Turjak - sensors (red line) and traffic signs (triangle).

At the end of the year 2017, the third dynamic traffic sign was installed along another highly problematic section of the state road Ljubljana – Kočevje (south from Turjak), which was approved by the EU Commission additionally (Figure 4, 5). It also helps to reduce vehicle collisions with brown bear and other wildlife by warning the drivers about approaching animal and therefore helps to reduce traffic caused bear mortality on another hot spot.

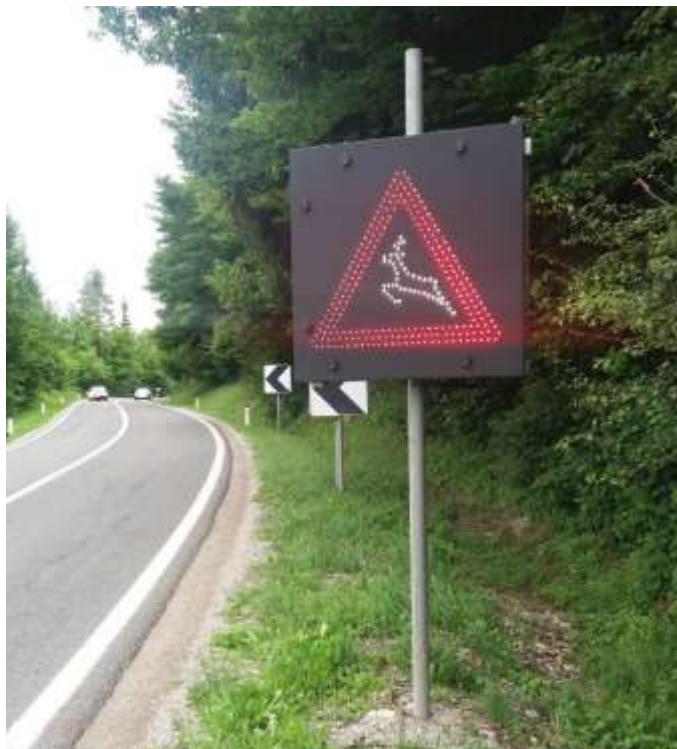
Figure 5: Dynamic traffic sign placed along the main road Ljubljana – Kočevje near Turjak (photo: I. Jelenko Turinek, 2018).

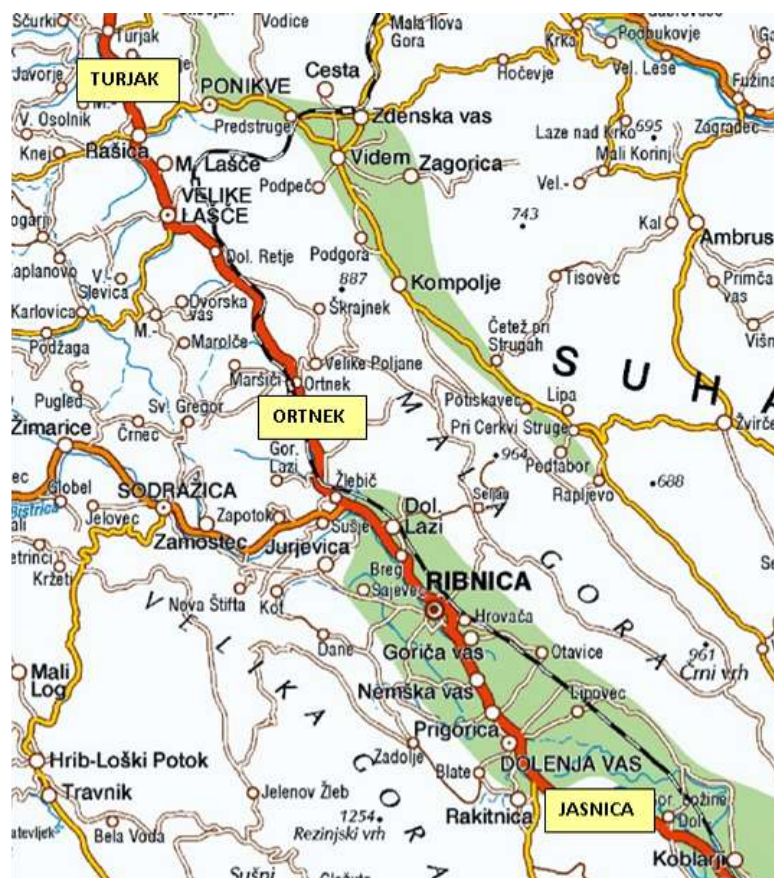
Figure 6 : Location of three dynamic signs systems along the main road Ljubljana – Kočevje.

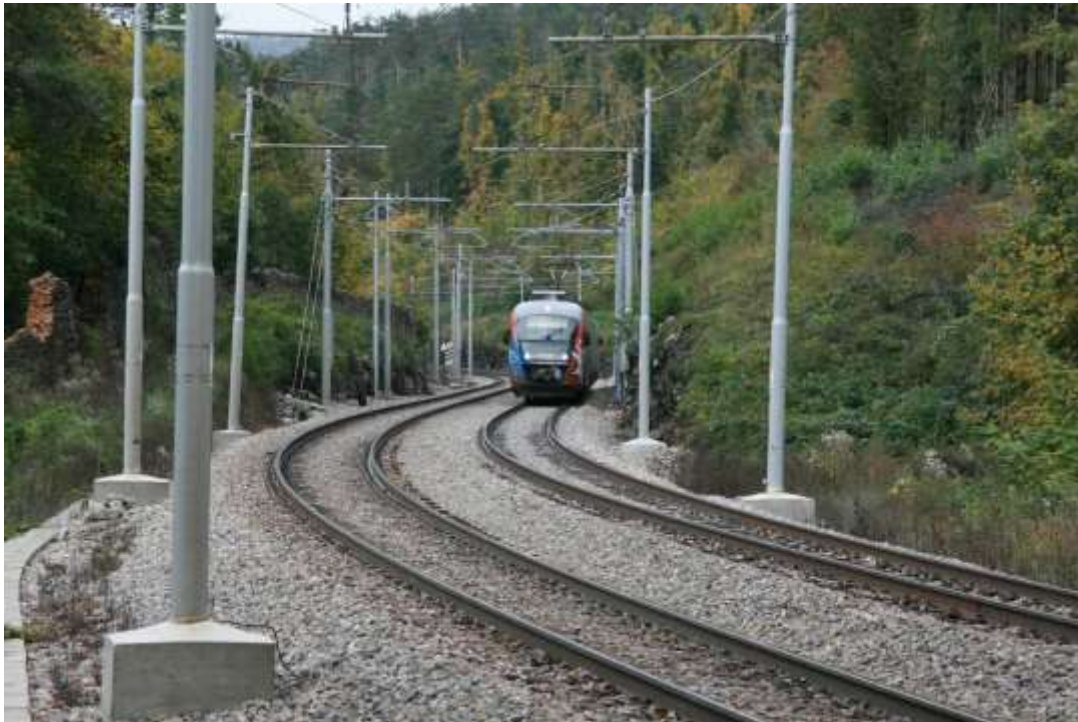
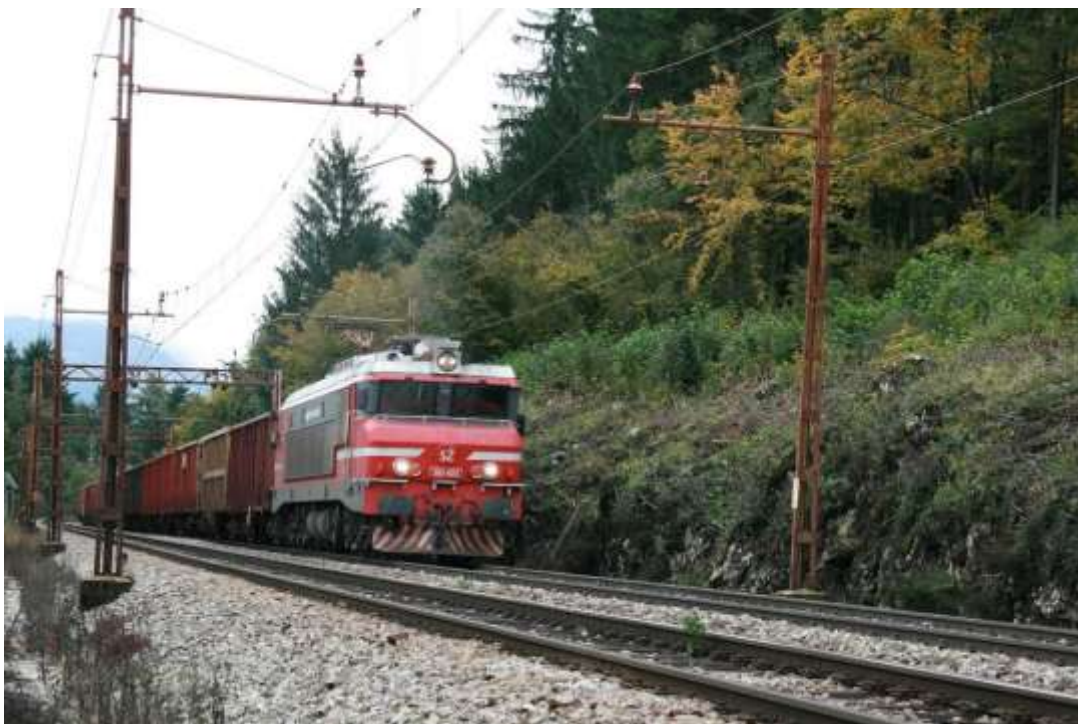
Figure 7: Two types of electric poles to which we installed acoustic deterrents (photo: Z. Pavšek, 2015).

At the end of 2015, acoustic deterrents were installed on electric poles along the railway sections Rakek – Postojna and Postojna – Prestranek, where it was stated by field inspection that crossing of wildlife (especially brown bear) is possible (see Figures 9, 10, 11).

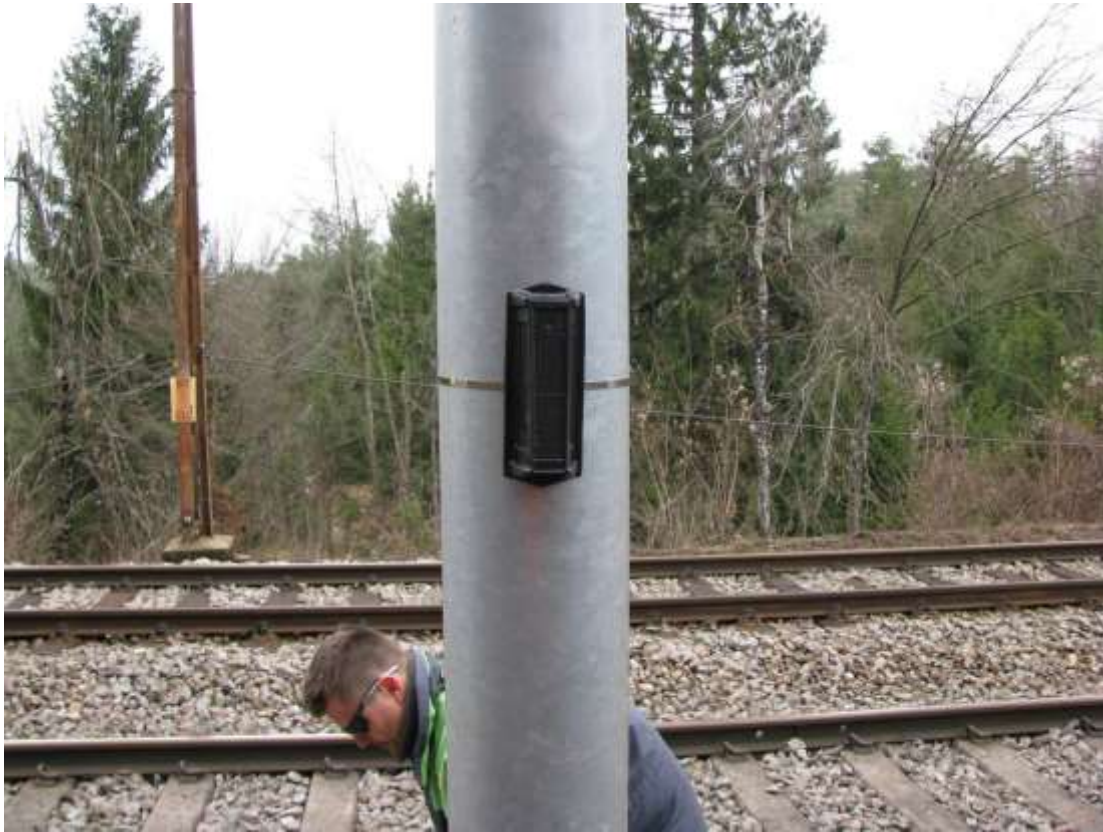
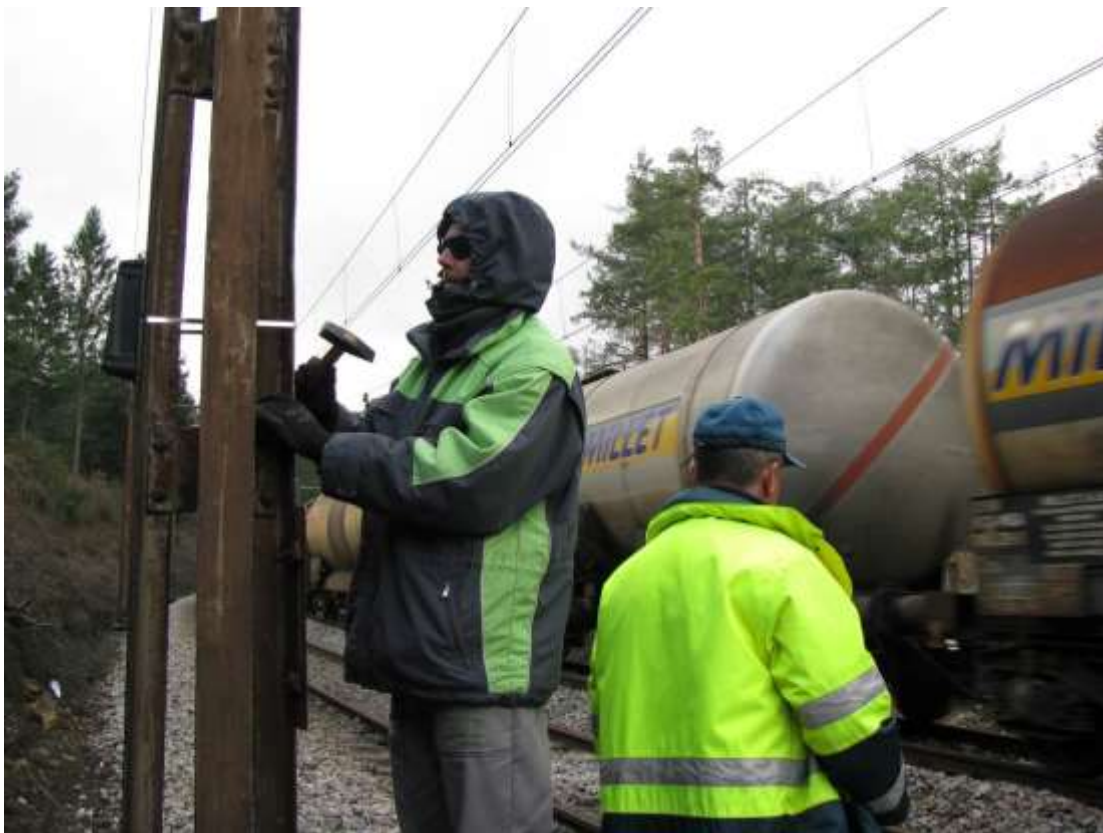
Figure 8: Installation of acoustic deterrents on electric poles along railway sections (photo: M. Zaluberšek, 2015).

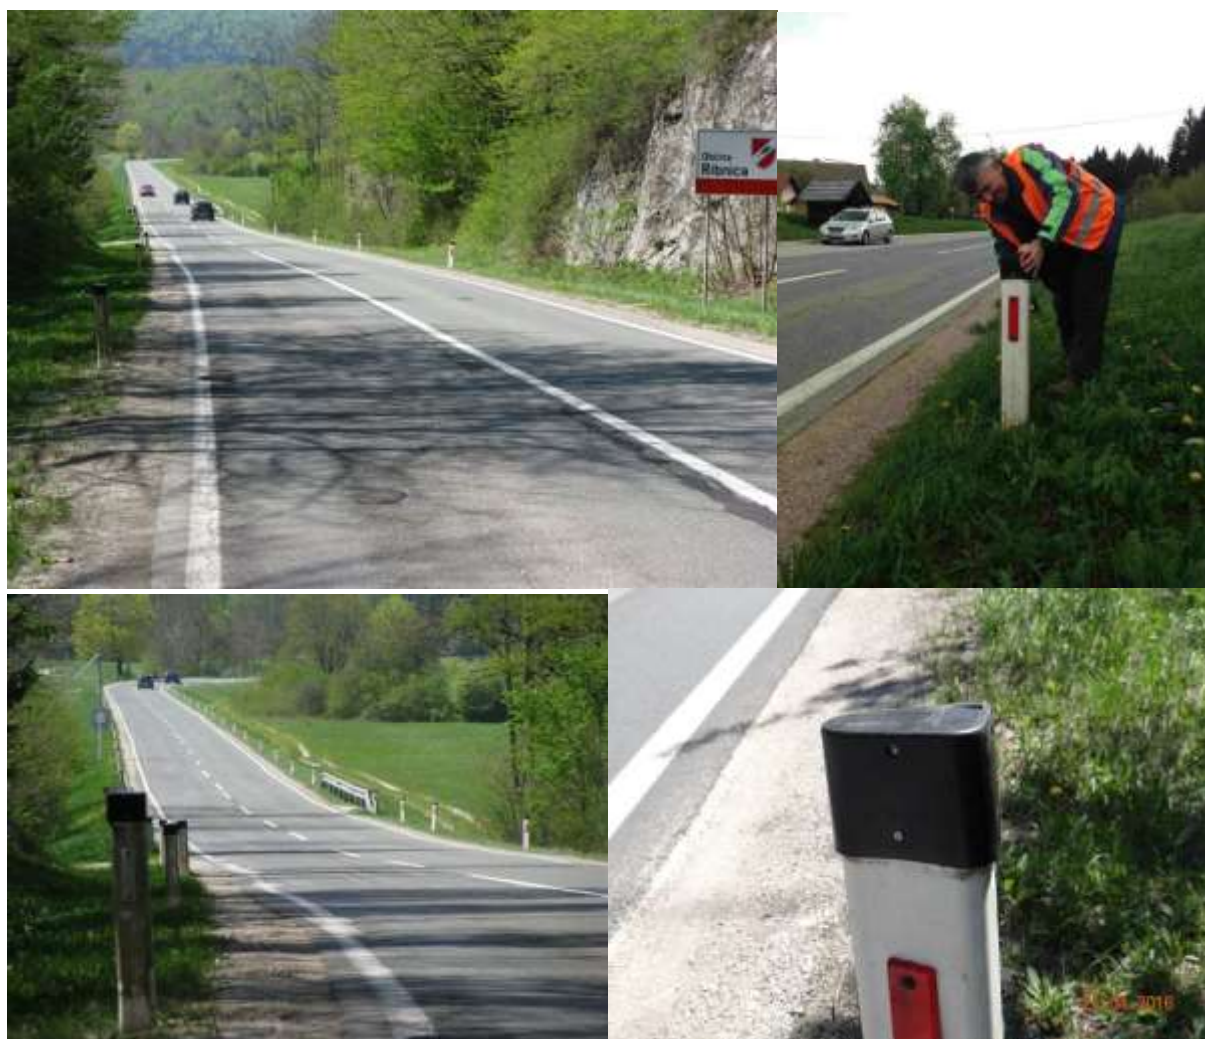
Figure 12: Acoustic deterrents installed along the main road Ljubljana – Kočevje (photo: M. Zaluberšek, 2016).

Acoustic deterrents (ultra- and infrasound emitting electronic devices coupled with sensors activating the sound by the approaching vehicle) were installed directly into the roadside trafficators/pillars along the 'black-spots' considering bear-vehicle collisions along the main road Ljubljana – Kočevje (Figures 13-16). In total, app. 7.5 km of roads are protected by 240 acoustic deterrents (Table 1).

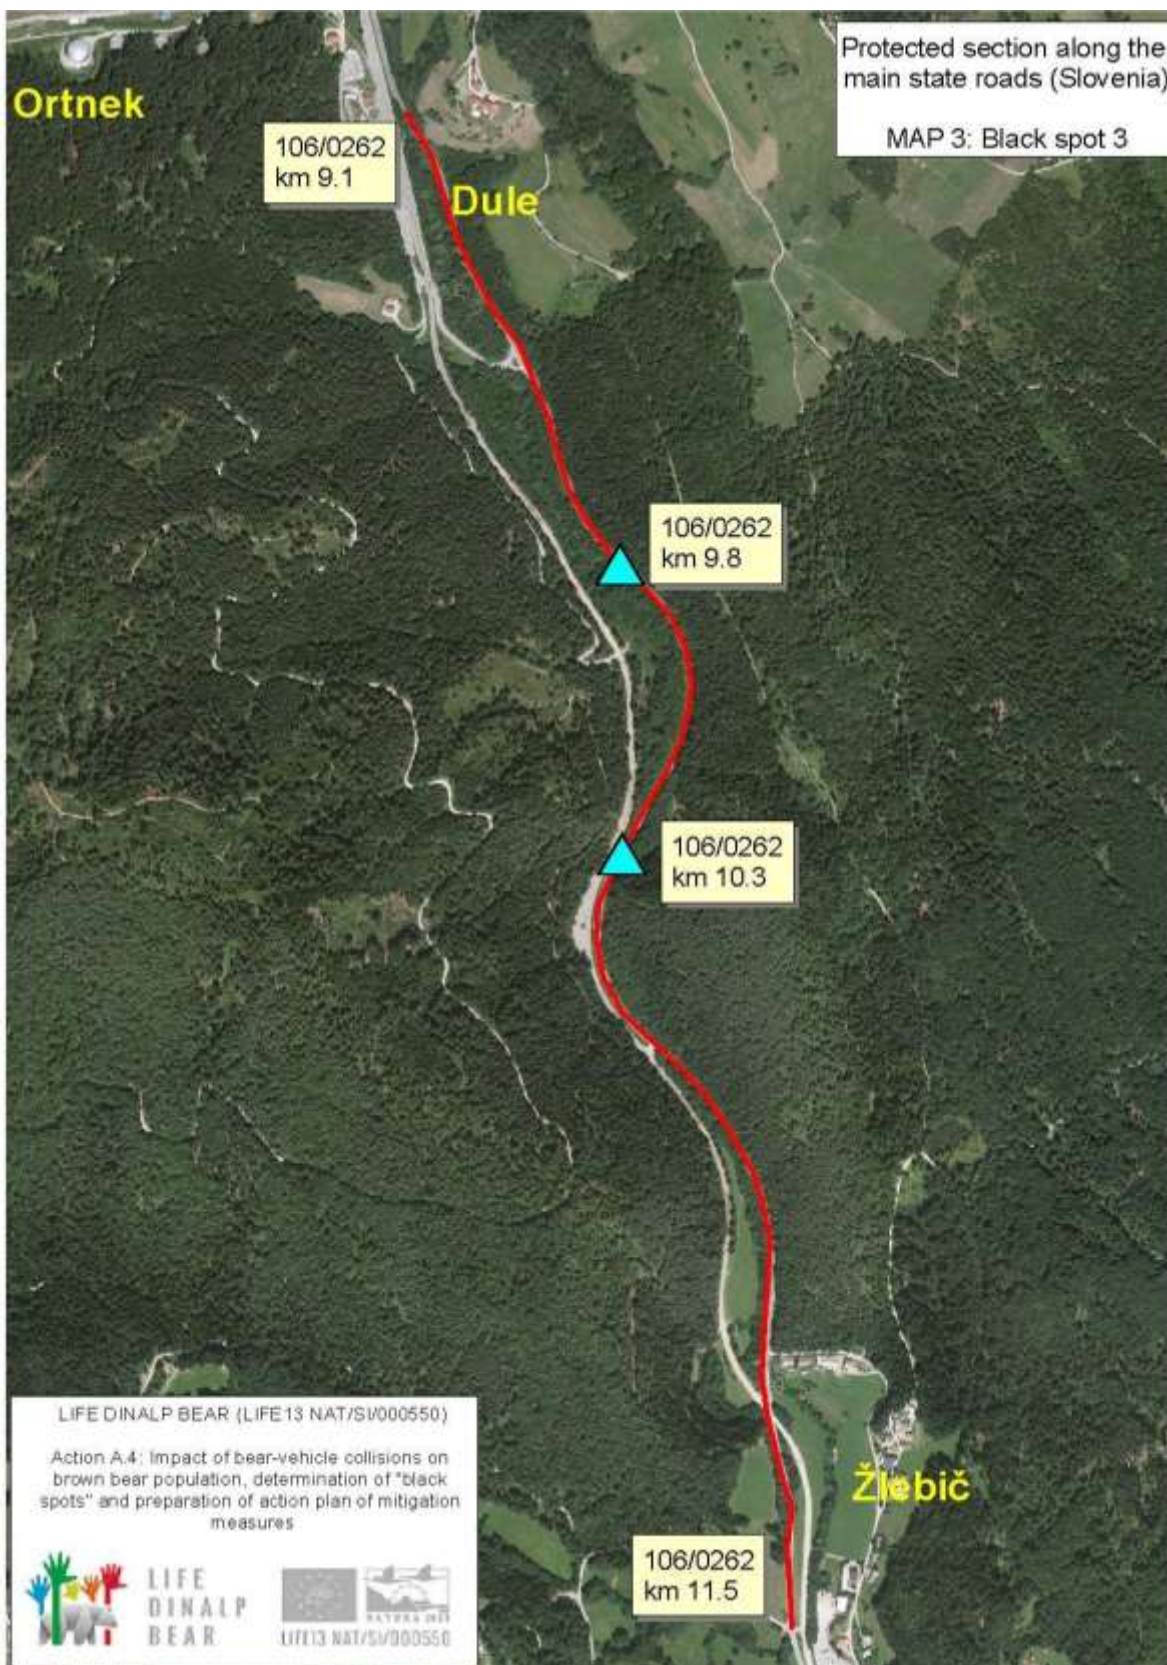
Figure 13: Selected road section along main road Ljubljana – Kočevje (between Ortnek and Žlebič), where acoustic deterrents are installed. Blue triangles represent dynamic traffic signs.

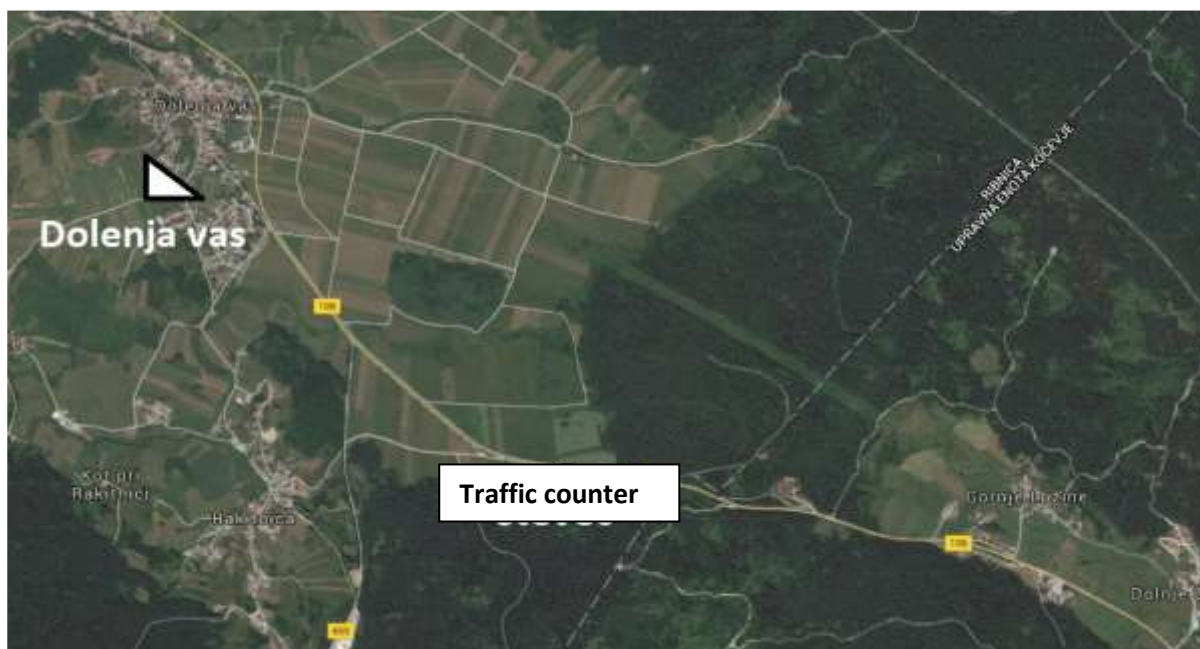
Figure 17: Map of location of traffic counter and driving direction along the main road Ljubljana – Kočevje (Jasnica) near Dolenja vas.

We have measured the speed of vehicles to allow comparison of speed of different type of vehicles before installation of dynamic traffic signs and after installation. The measuring device Viacount II or traffic counter was placed on the main road Ljubljana - Kočevje between the villages Dolenja vas and Gornje Ložine (Jasnica) in the period between 9 November 2015 (12:00) and 23 November 2015 (12:00) (before installation of dynamic traffic signs on this road section) (Grebenc, 2015). Driving direction and location of measuring device are shown on the map below (see Figures 17, 18).

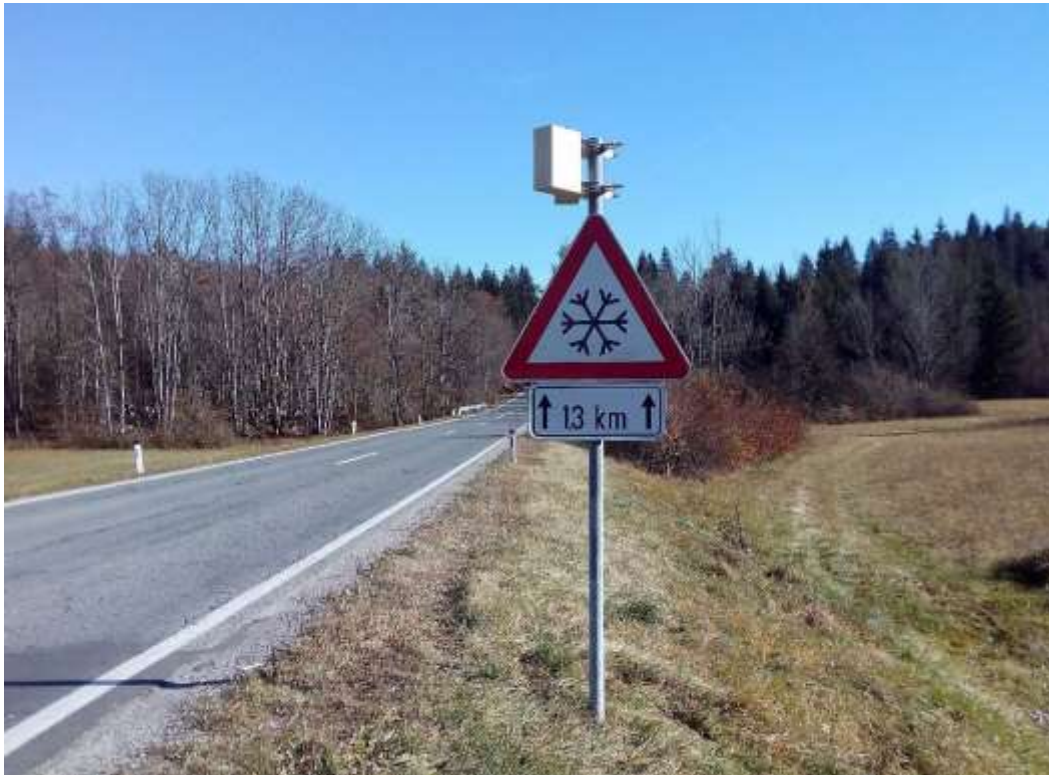
Figure 19: Traffic counter placed on the pole of traffic sign near Dolenja vas (Jasnica).

Traffic counter Viacount II is radar device for counting and classification of vehicles according to the type of vehicle. Based on the Doppler method of measurement it provides accurate and reliable measurements. The device enables the counting and measurement of the speed of vehicles in both directions, e.g. incoming and outgoing traffic. Traffic counter was placed on the pole of traffic sign at a height of 2.3 m and 1.9 m away from the road (Figure 19). Speed limit in this section of the main road is 90 km/h.

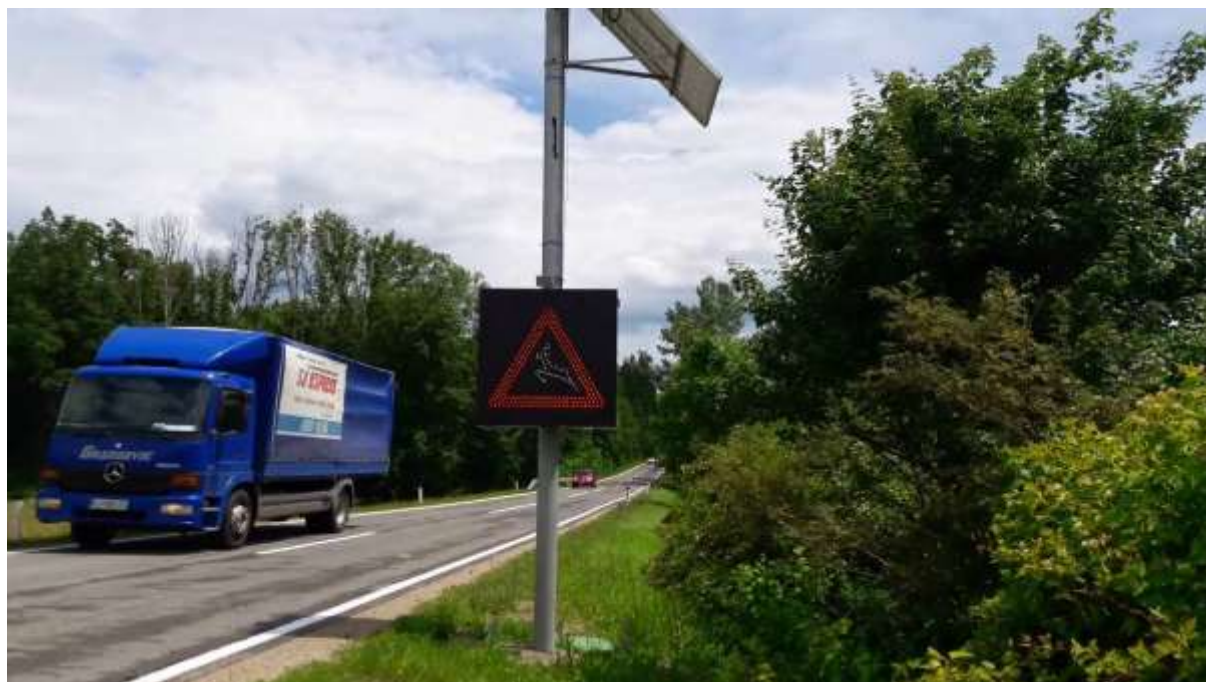
Figure 21: Active dynamic sign at Jasnica (photo: Z. Pavšek, 2016).

Location / Period	Average speed (km/h)	Average speed during inactive dynamic signs (km/h)	Average speed during active dynamic signs (km/h)
Ortnek: 7.2. – 12.12.2017	71.5	75.9	69.0
Jasnica: 8.3. – 20.12.2017	81.1	87.2	69.1

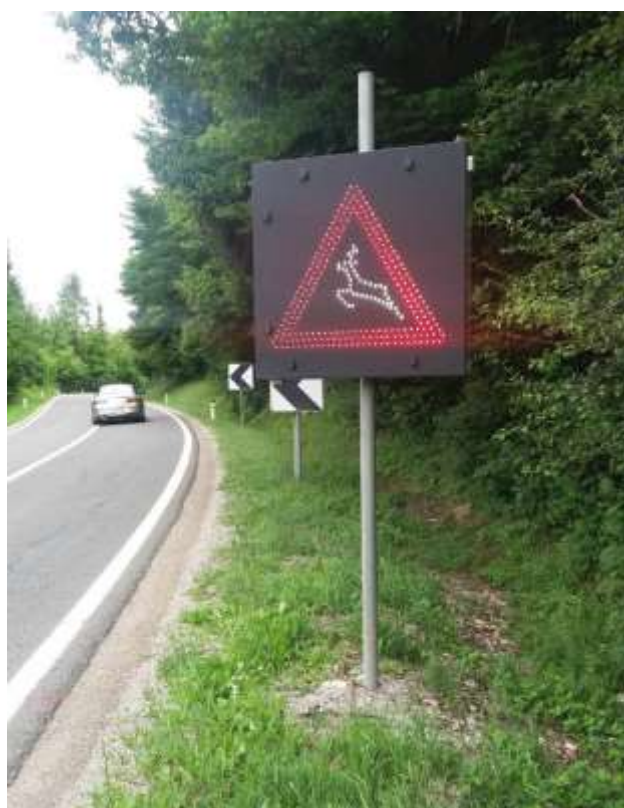
Figure 22: Active dynamic sign at Turjak (photo: I. Jelenko Turinek, 2018).

Location / Period	Average speed (km/h)	Average speed during inactive dynamic signs (km/h)	Average speed during active dynamic signs (km/h)
Jasnica: 15.2. – 20.7.2018	84.6	84.9	79.3
Turjak: 7.2. – 20.7.2018	69.9	72.2	66.6

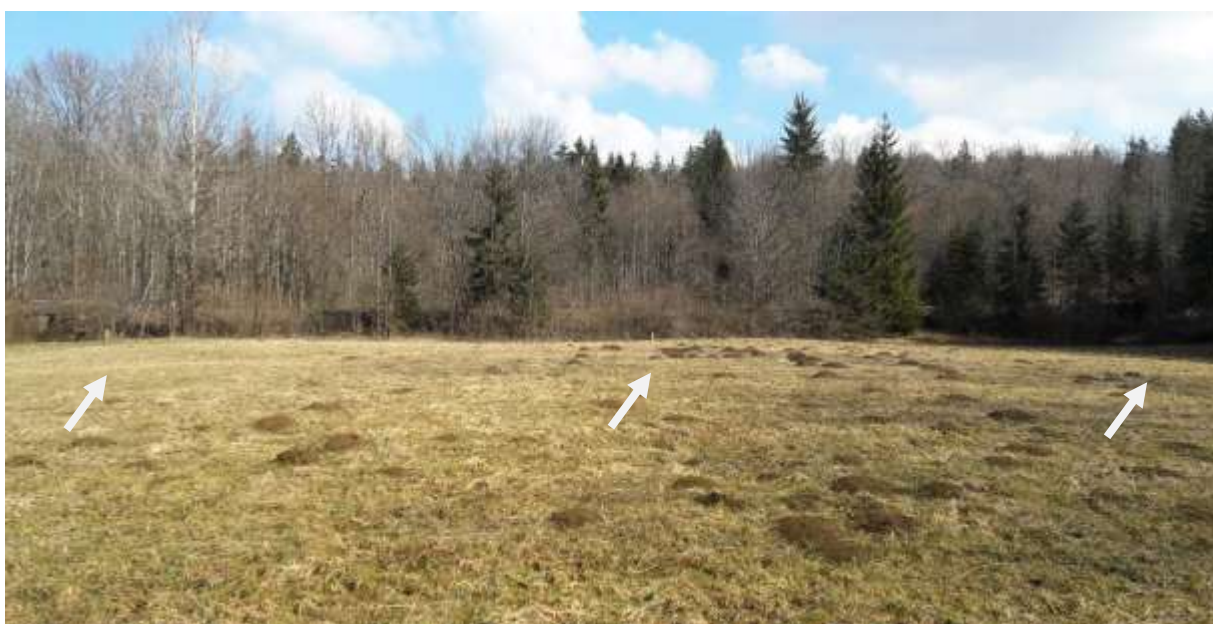
Figure 24: Meadow near main road at Jasnica, where camera was placed and wildlife was frequently detected (arrows indicate sensors in wooden stumps capable to detect large animals approaching the roadways) (photo: S. Al Sayegh Petkovšek, 2016).

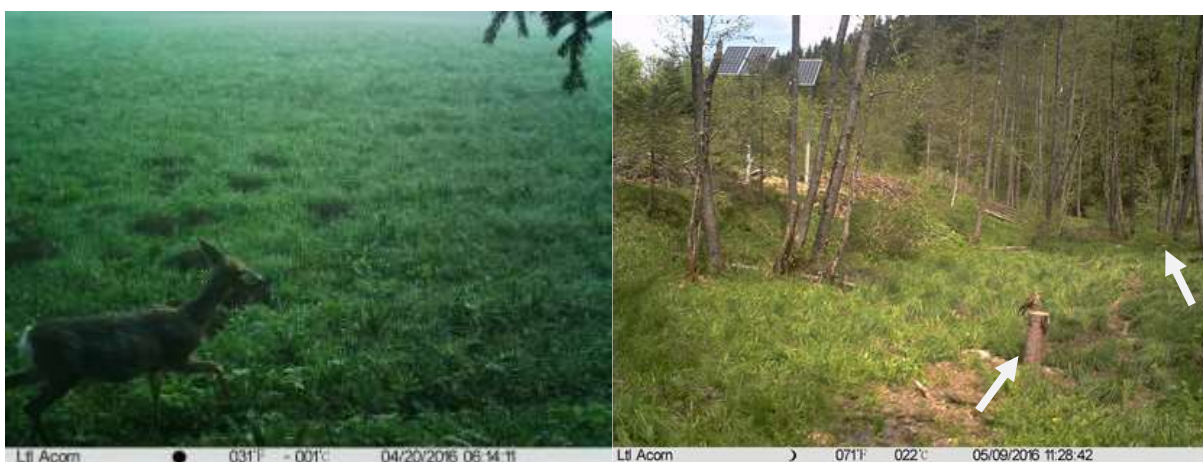
Figure 25: Images captured by the camera at Jasnica (left) and Ortnek (right) (arrows indicate sensors).

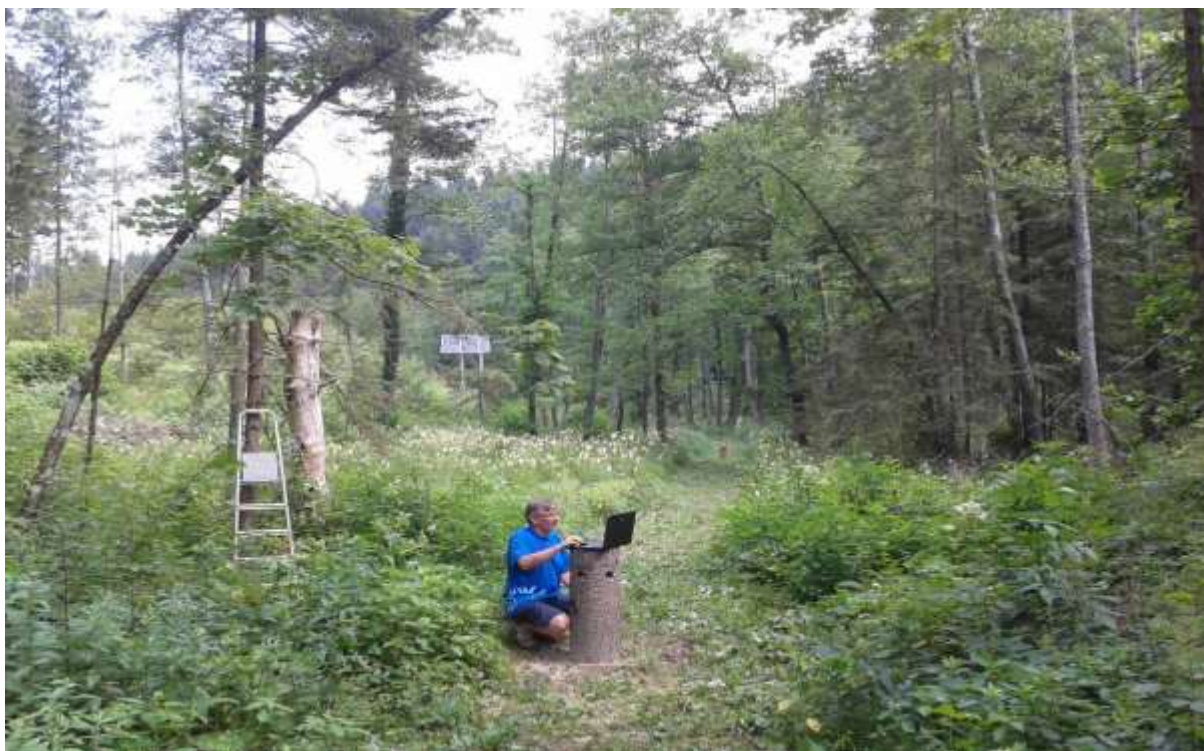
Figure 26: Data collection from cameras at Ortnek (photo: S. Al Sayegh Petkovšek, 2016).

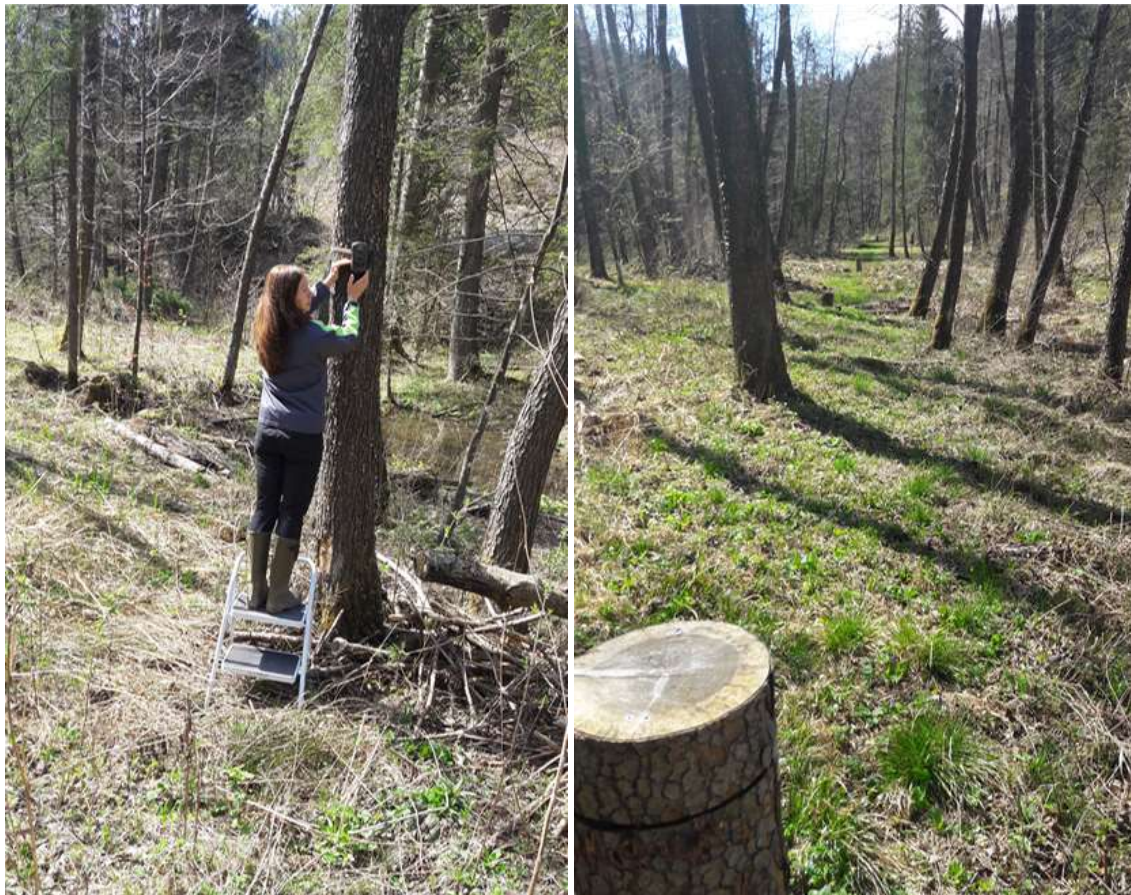
Figure 35: Installation of IR cameras at Ortnek and sensors in wooden stumps capable to detect large animals approaching the roadway (photo: Z. Pavšek, 2017).

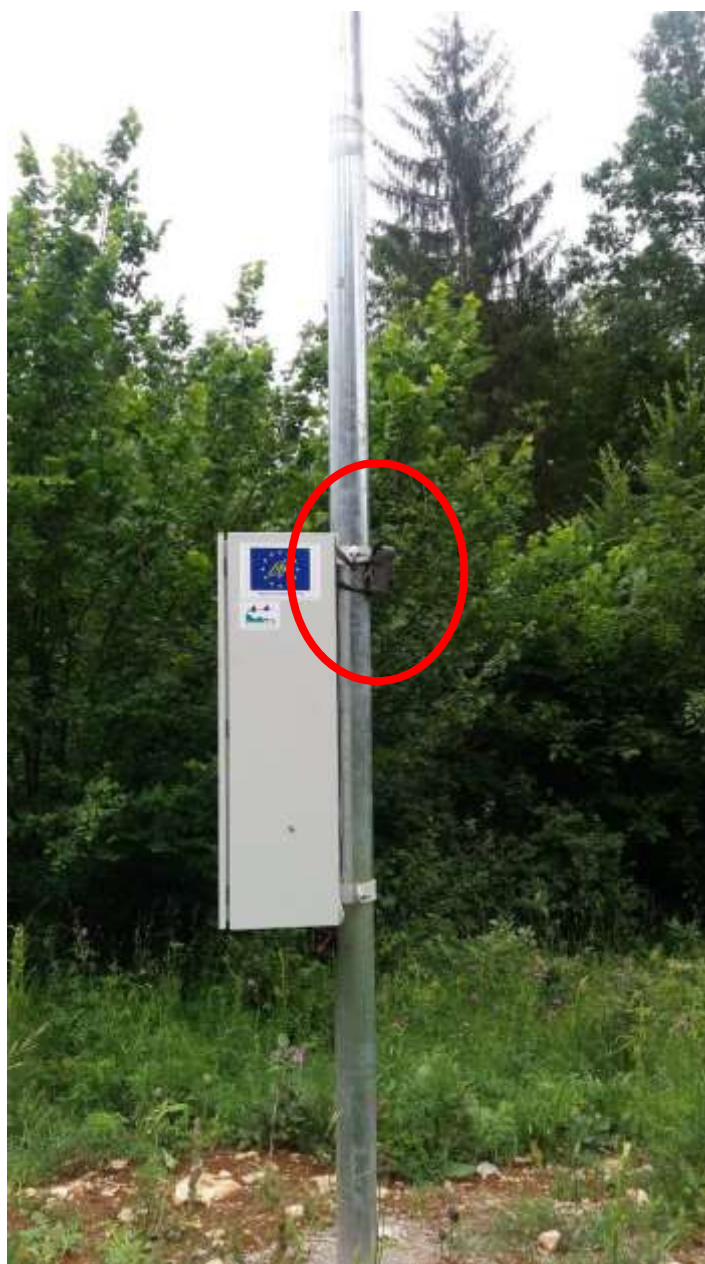
Figure 49: Installation of IR camera at Turjak, near the road Ljubljana – Kočevje; location where animals, that want to cross the road at this section, usually pas (photo: I. Jelenko Turinek, 2018).

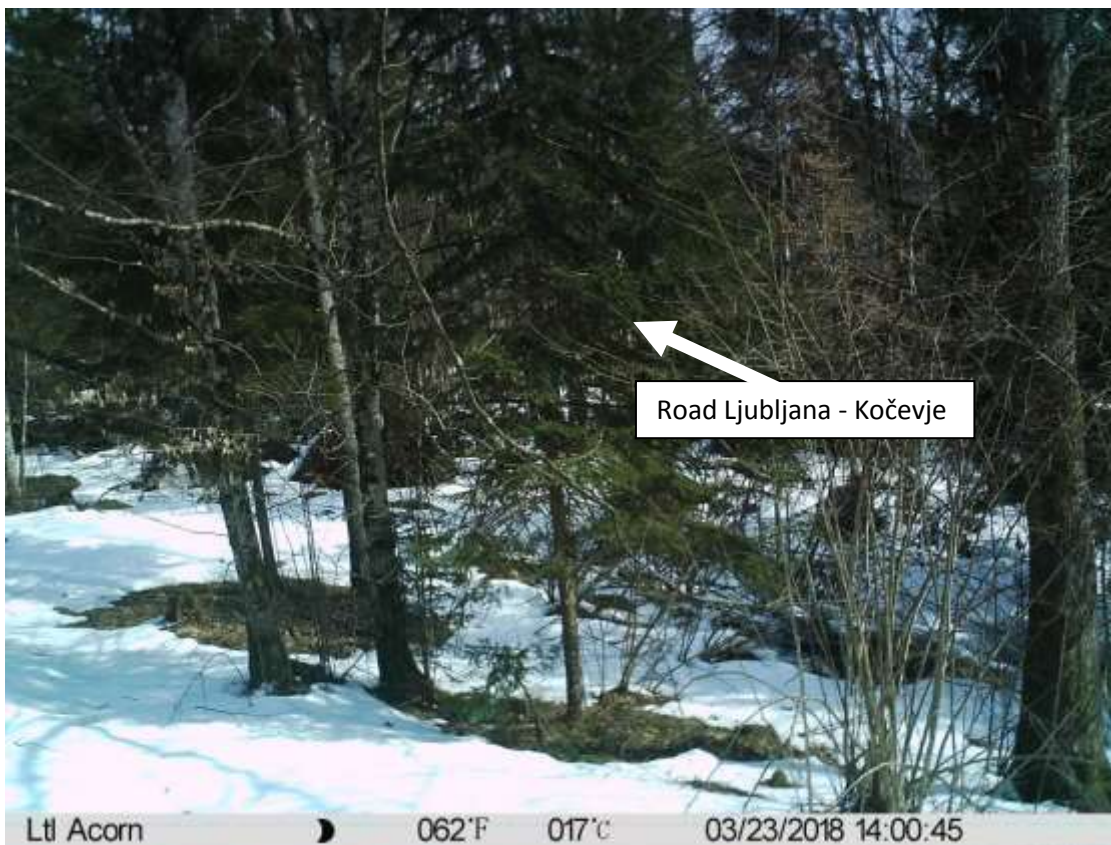
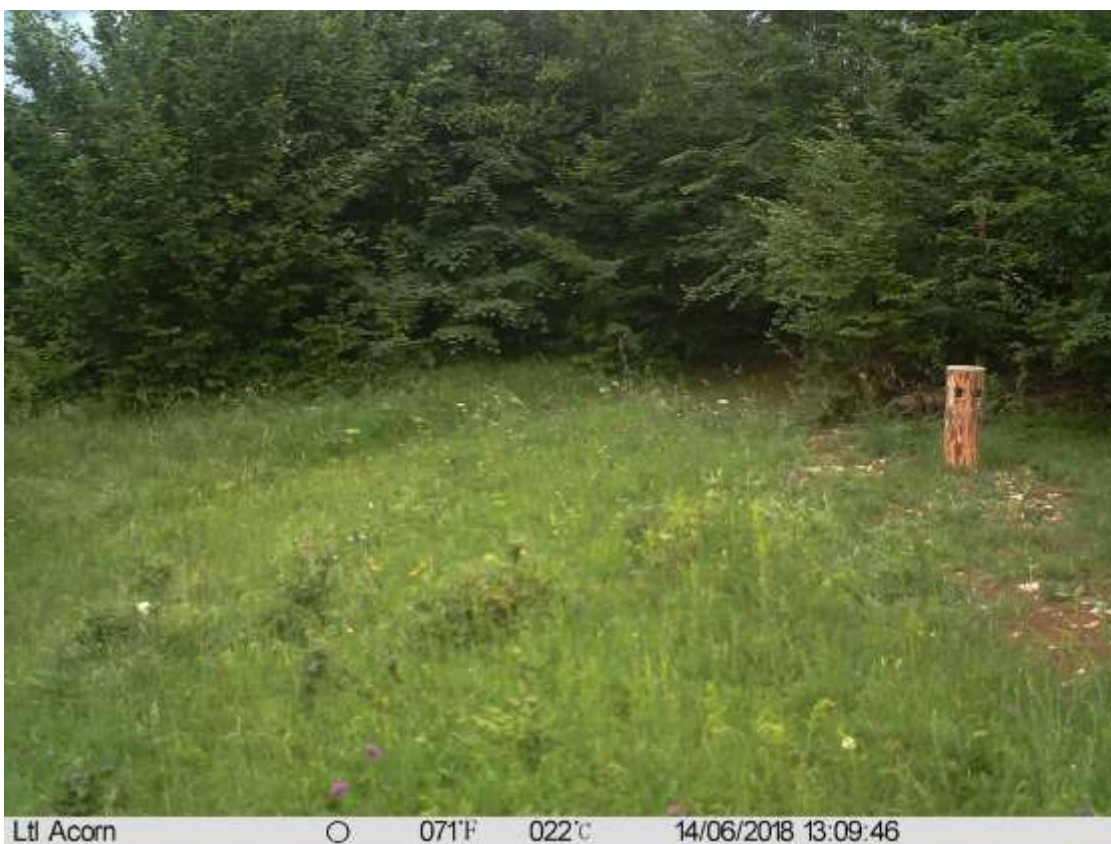
Figure 50: Location of filming with IR camera at Turjak, near the road Ljubljana – Kočevje; here animals, that want to cross the road, usually pas (photo: IR camera, 2018).
