MONITORING OF THE EFFECTIVENESS OF MITIGATION MEASURES IN SLOVENIA

Action D.2: Evaluation (monitoring) of the effectiveness of mitigation measures implemented to prevent traffic related bear mortality

Title of the project: **LIFE DINALP BEAR (LIFE13 NAT/SI/000550): Population level management and conservation of brown bears in northern Dinaric Mountains and the Alps**

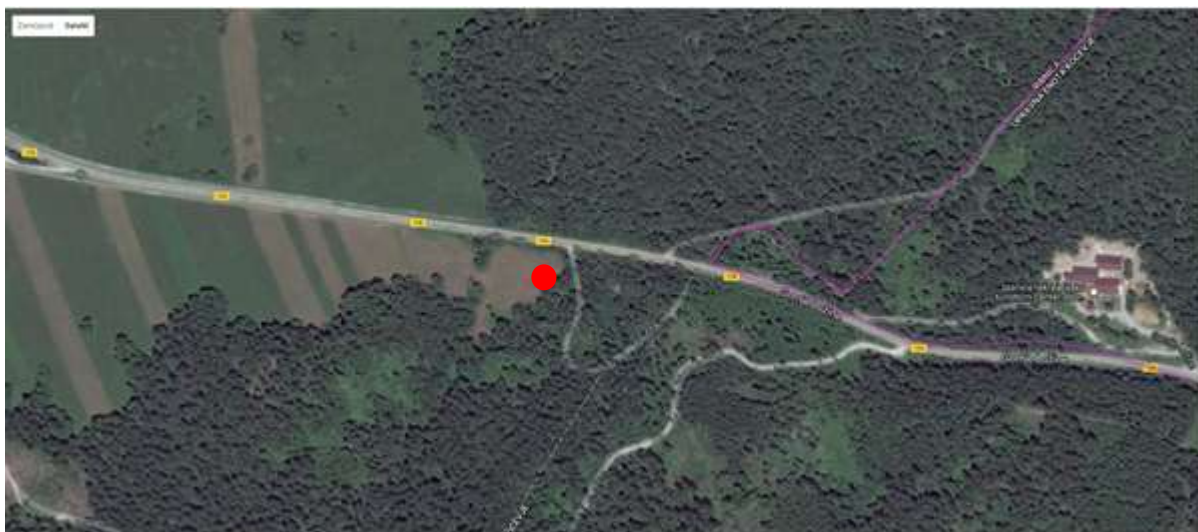
Figure 55: Location of traffic related bear mortality near Jasnica (main road Ljubljana – Kočevje) in 2015 – BEFORE acoustic deterrents were installed. Red dot means the location of found bear/carcass.

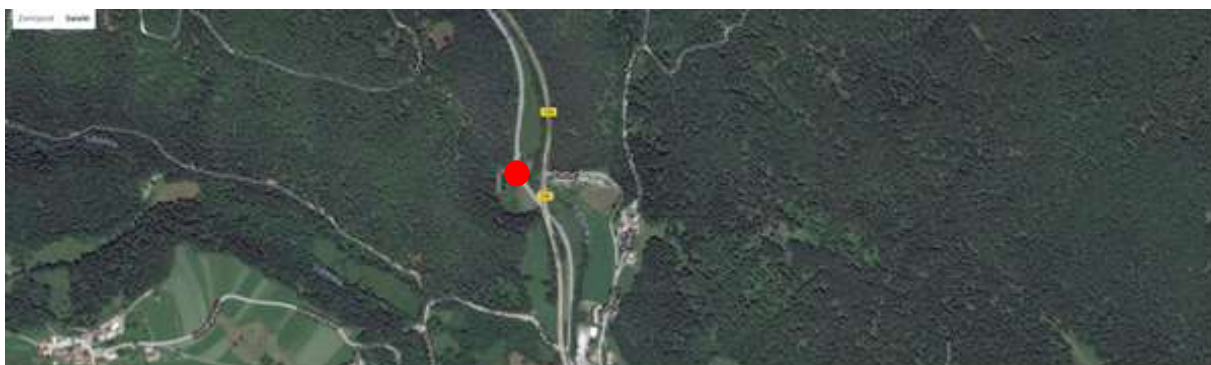
Figure 56: Location of traffic related bear mortality at Ortnek, Žlebič (29th September 2016) – with acoustic deterrents protected section of main road Ljubljana – Kočevje. Red dot means the location of found bear/carcass.

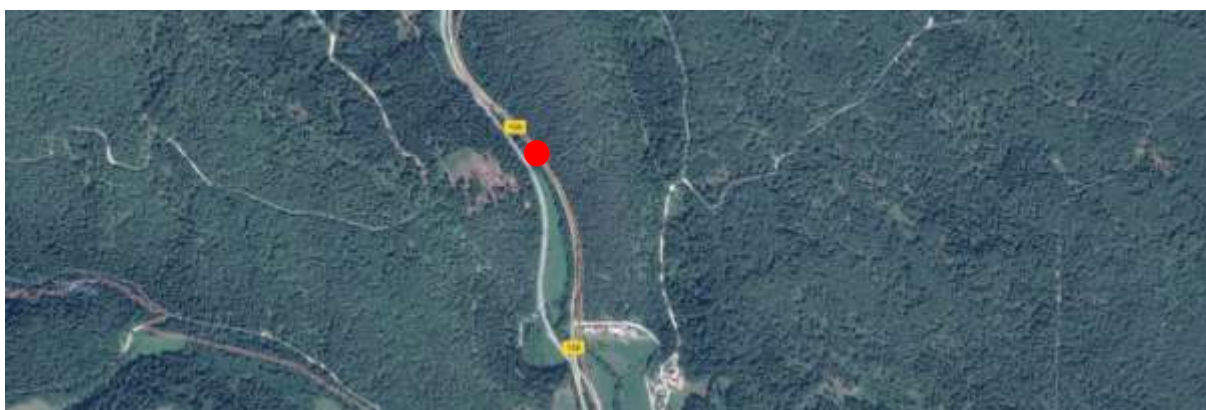
Figure 57: Location of traffic related bear mortality at Ortnek, Žlebič (26th October 2017) – with acoustic deterrents protected section of main road Ljubljana – Kočevje. Red dot means the location of found bear/carcass.

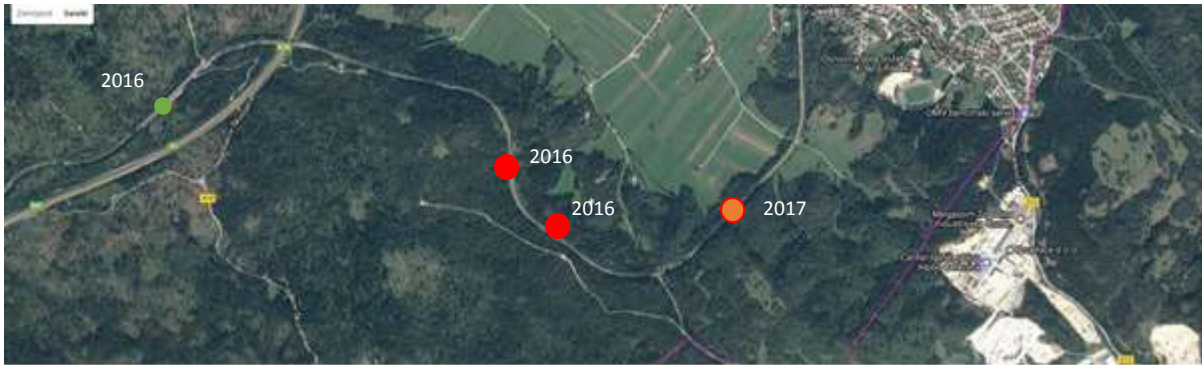
Figure 58: Location of traffic related bear mortality near Rakek (9th August and 10th December 2016 and 4th May 2017) – with acoustic deterrents protected section of the railway Rakek – Unec. Red dot means the location of found bear/carcass. Green dot means the bear mortality case at NOT protected railway section.

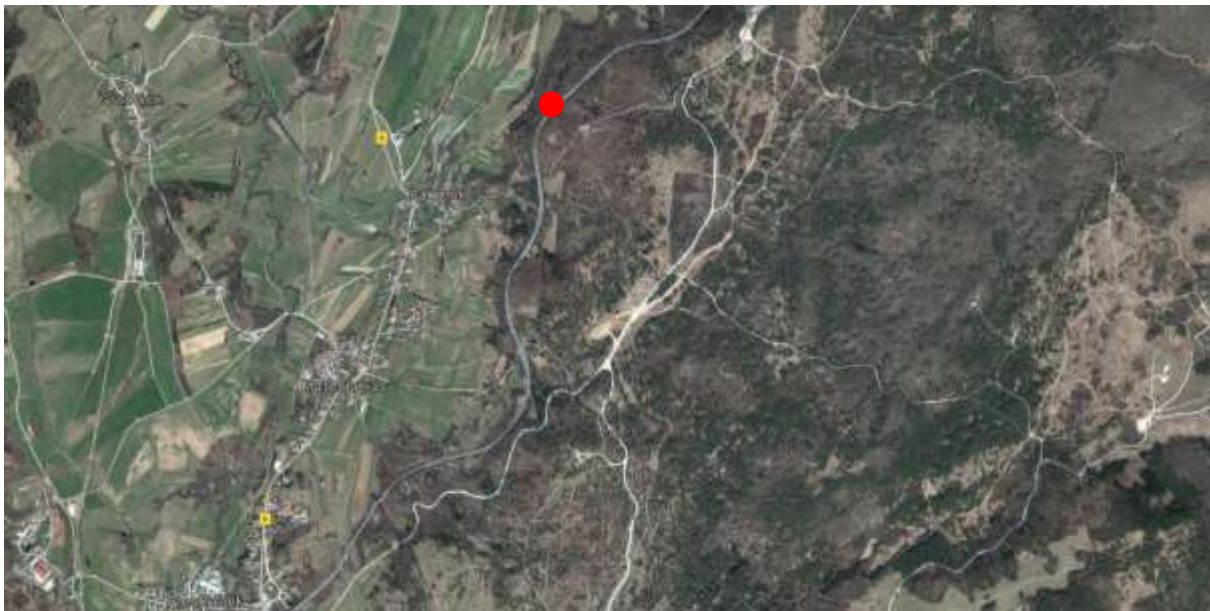
Figure 59: Location of traffic related bear mortality near Rakitnik, Prestranek (24th February 2018) – with acoustic deterrents protected section of main road Ljubljana – Kočevje. Red dot means the location of found bear/carcass.
