LIFE  
DINALP  
BEAR

Population level management and  
conservation of brown bears in northern  
Dinaric Mountains and the Alps

# MONITORING OF THE EFFECTIVENESS OF MITIGATION MEASURES IN SLOVENIA

*Action D.2: Evaluation (monitoring) of the  
effectiveness of mitigation measures  
implemented to prevent traffic related  
bear mortality*

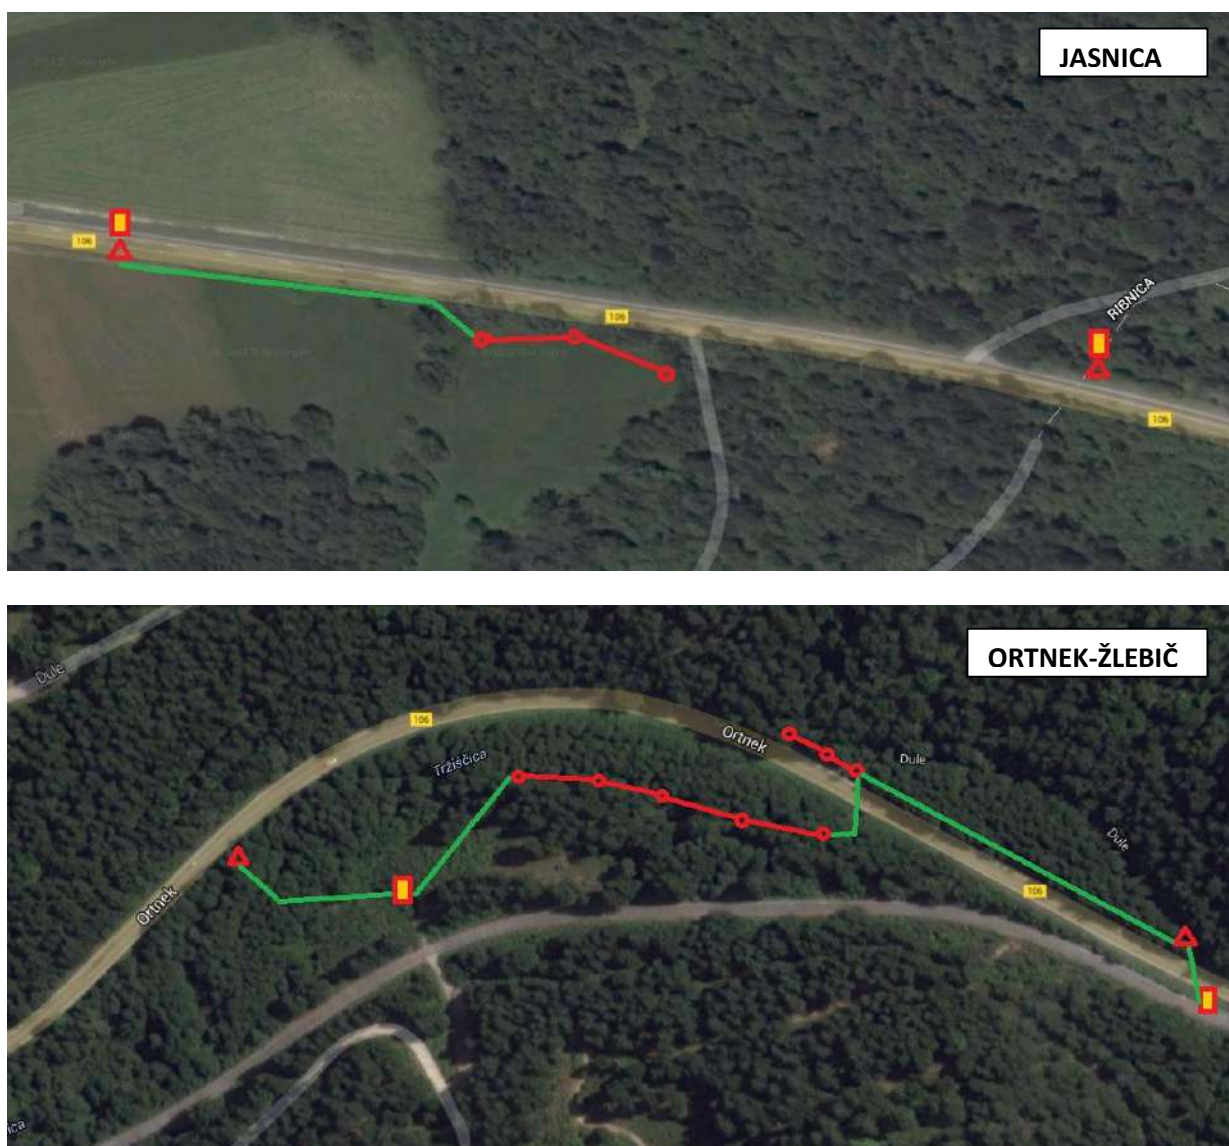
Figure 2: Dynamic traffic signs are coupled to sensors (red line), power lines (green line), solar cells (yellow rectangle) and traffic signs (triangle).

Dynamic traffic signs were placed along two sections of the main road Ljubljana – Kočevje (between Zgornje Lozine and Dolenja vas (Jasnica) and between Ortnek and Žlebič) to alert and slow down drivers in order to avoid potential collisions with wildlife, including bears. Dynamic signs are coupled to sensors capable to detect large animals approaching to the roadways (see Figure 2). In the case of approaching bear (or ungulates), the signs light on and send the message to the driver that an animal is approaching the road. Since the sensors are not bear-specific, they provide also higher road-safety considering collisions with other large mammals, particularly ungulates.

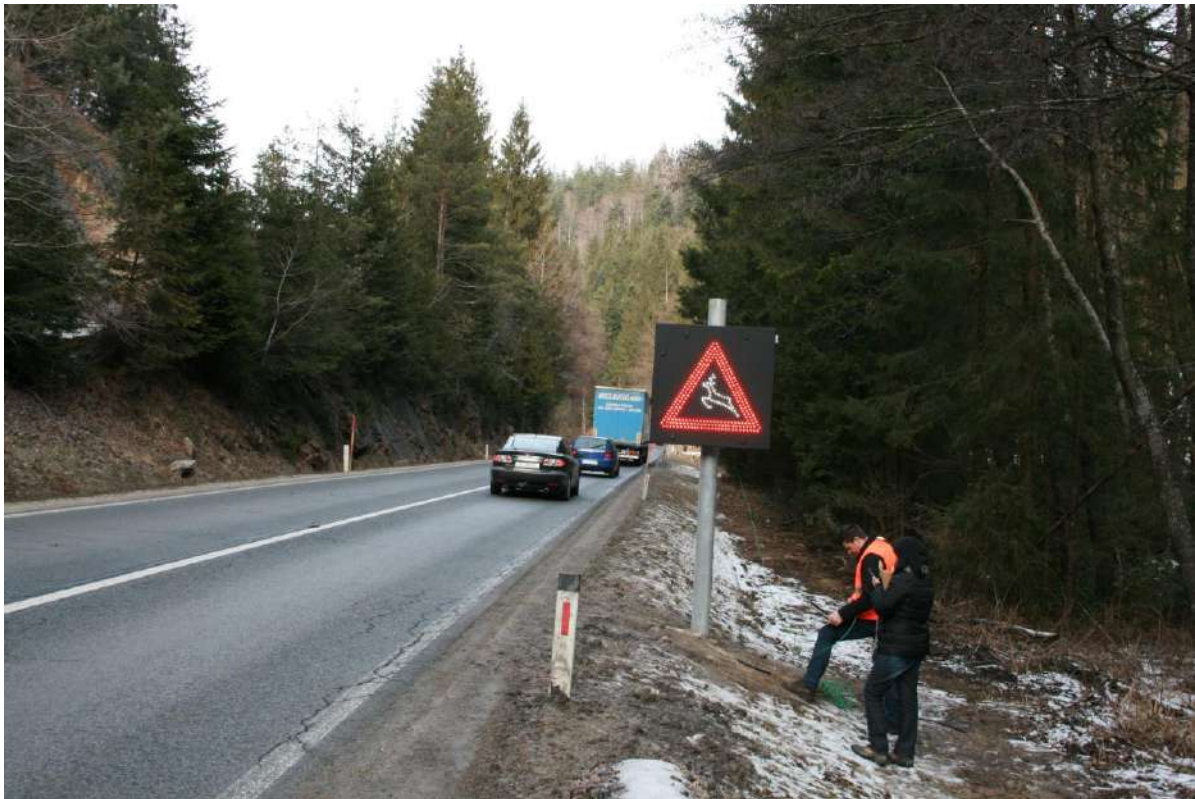
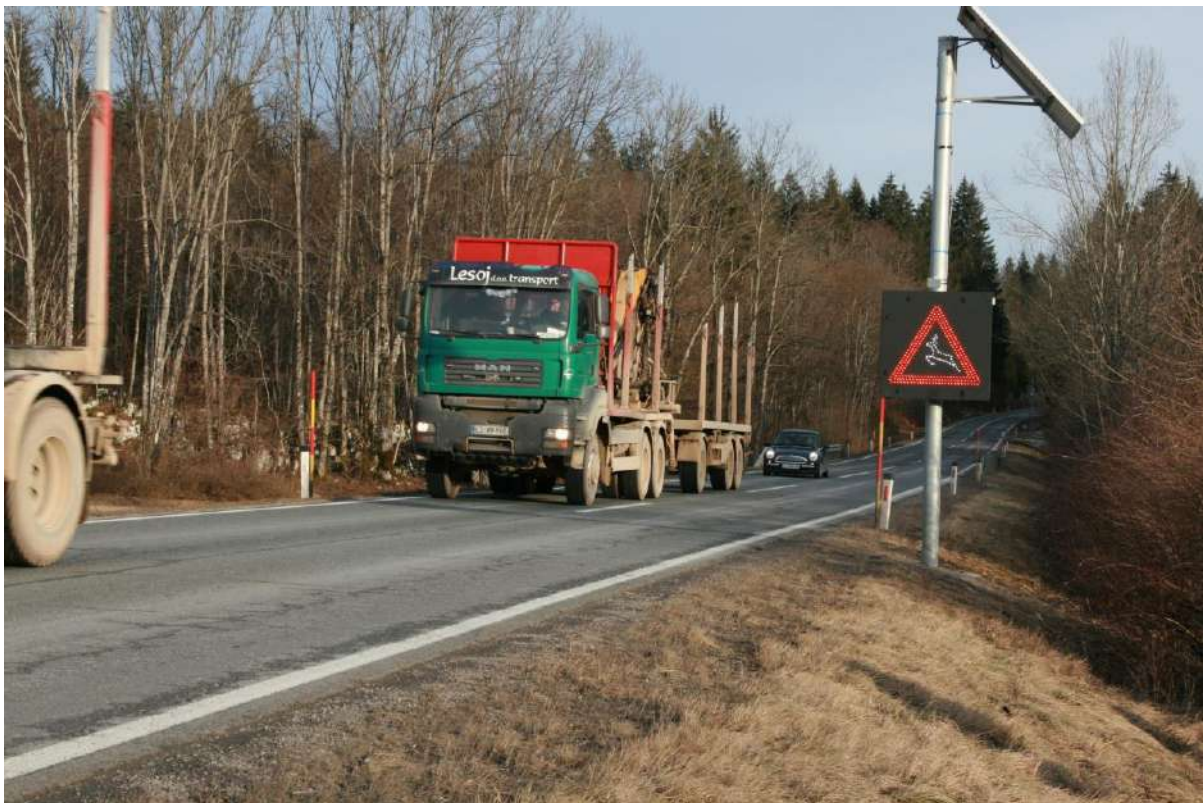
Figure 3: Dynamic traffic signs were placed along two sections of the main road Ljubljana – Kočevje (above: Ortnek; below: Jasnica) (photo: Z. Pavšek, 2016).

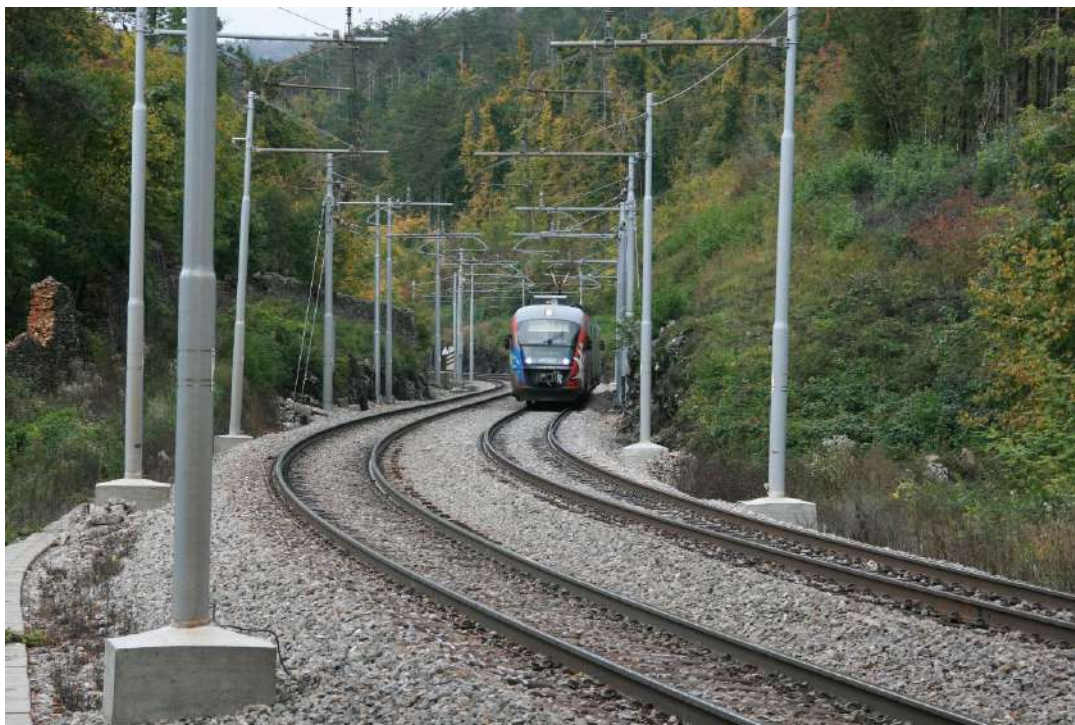
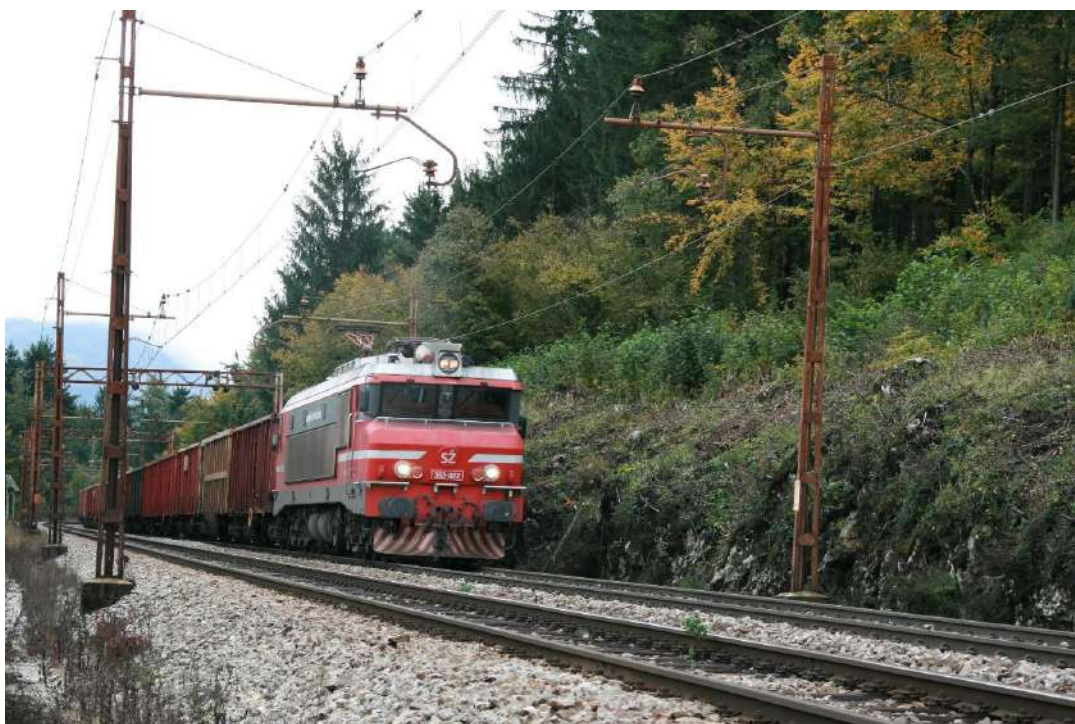
Figure 4: Two types of electric poles to which we installed acoustic deterrents (photo: Z. Pavšek, 2015).

Acoustic deterrents were installed on electric poles along the railway sections Rakek – Postojna and Postojna – Prestranek, where it was stated by field inspection that crossing of wildlife (especially brown bear) is possible (see Figures 5, 6, 7).

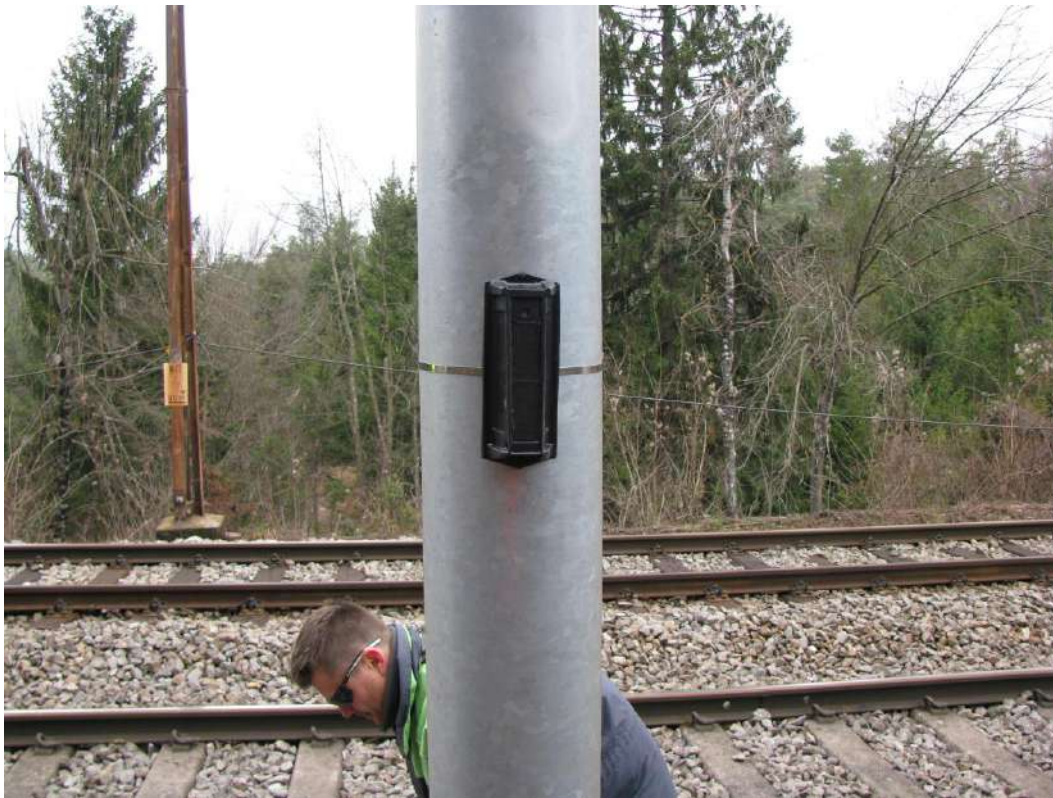
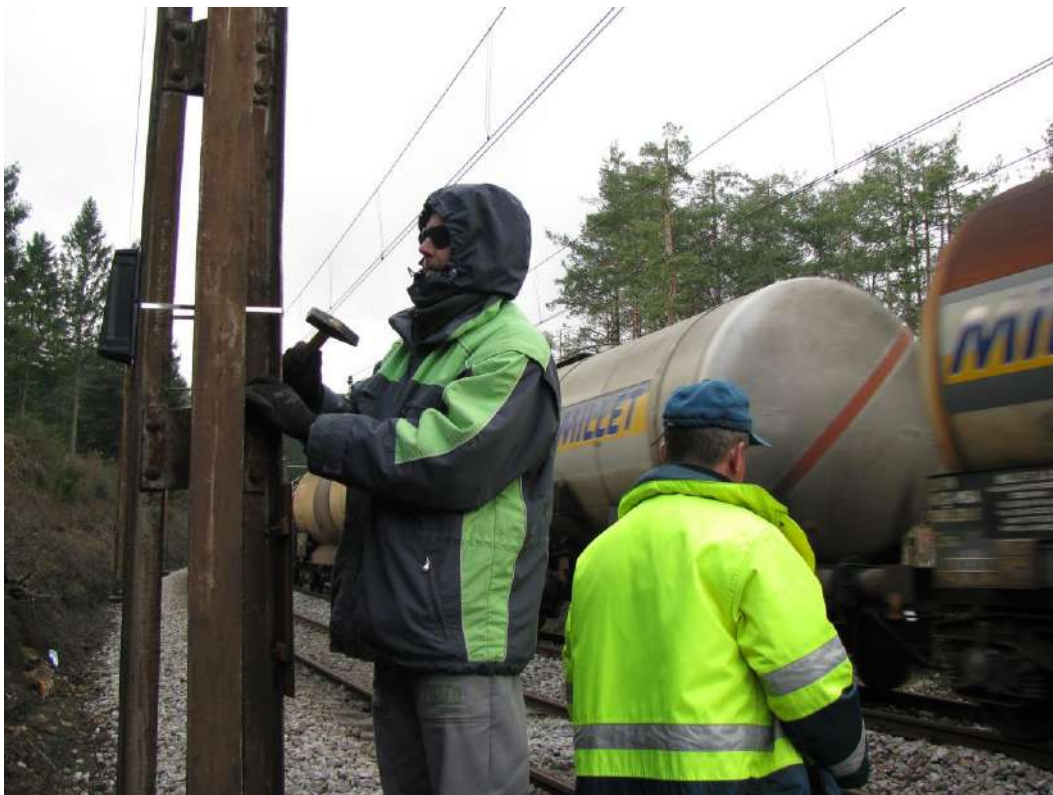
Figure 5: Installation of acoustic deterrents on electric poles along railway sections (photo: M. Zaluberšek, 2015).

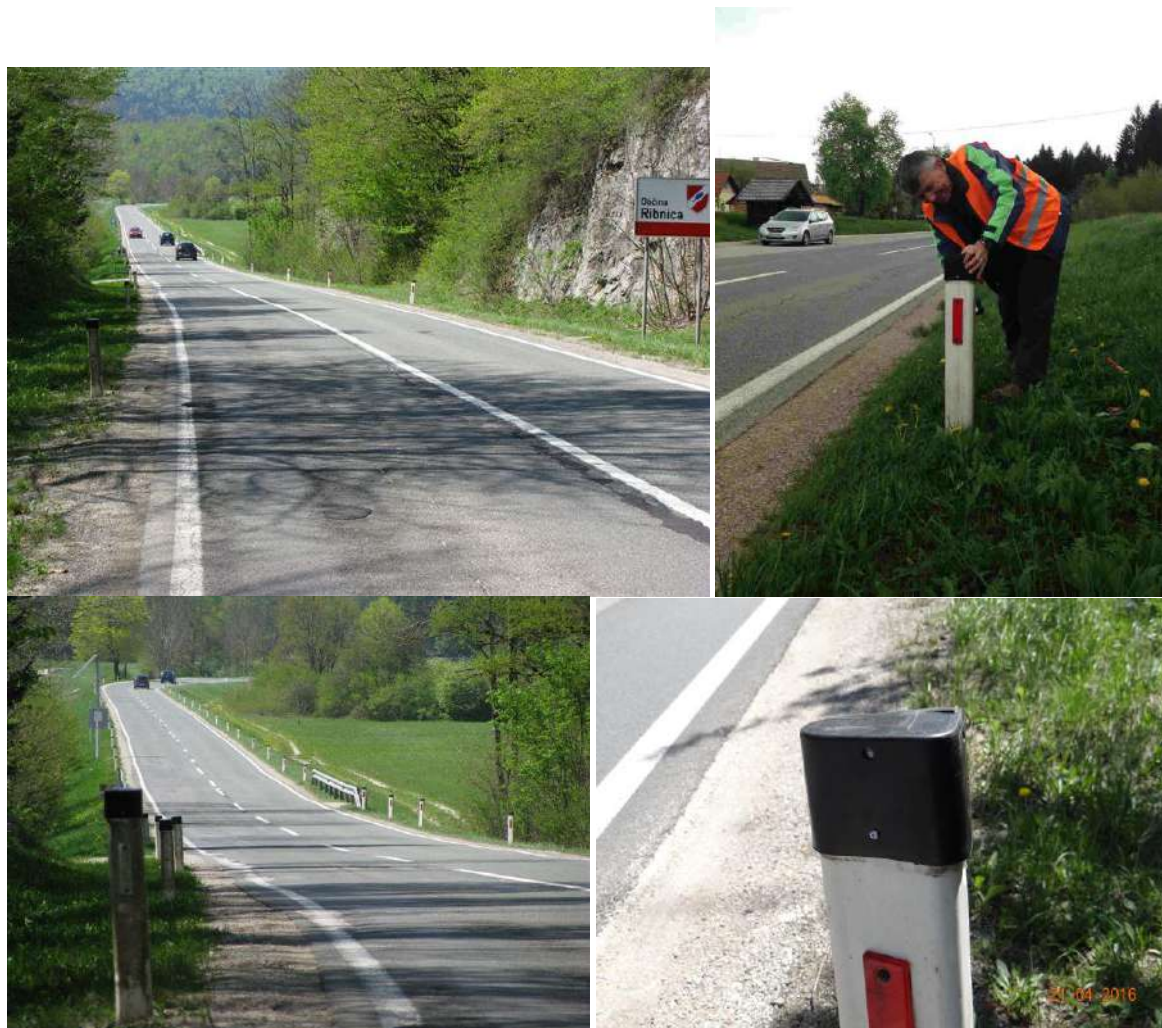
Figure 9: Acoustic deterrents were installed along the main road Ljubljana – Kočevje (photo: M. Zaluberšek, 2016).

Acoustic deterrents (ultra- and infrasound emitting electronic devices coupled with sensors activating the sound by the approaching vehicle) were installed directly into the roadside trafficators/pillars along the 'black-spots' considering bear-vehicle collisions along the main road Ljubljana – Kočevje (Figures 10-13). In total, app. 6 km of roads are protected by 240 acoustic deterrents.

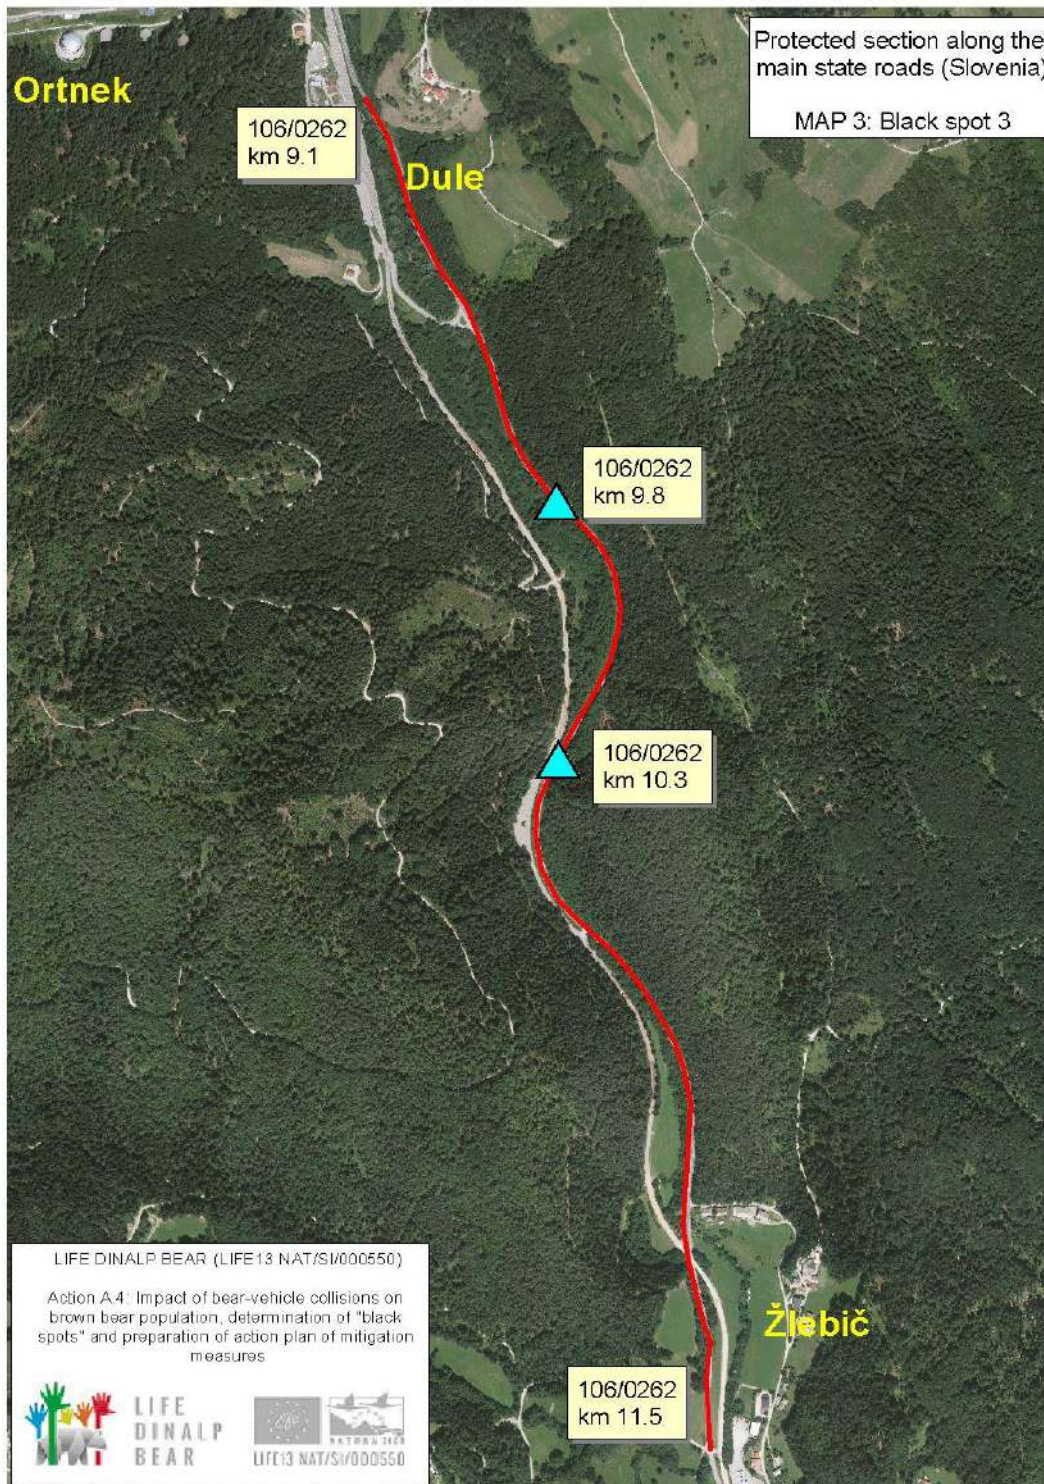
Figure 10: Selected road section along main road Ljubljana – Kočevje (between Ortnek and Žlebič), where acoustic deterrents were installed.

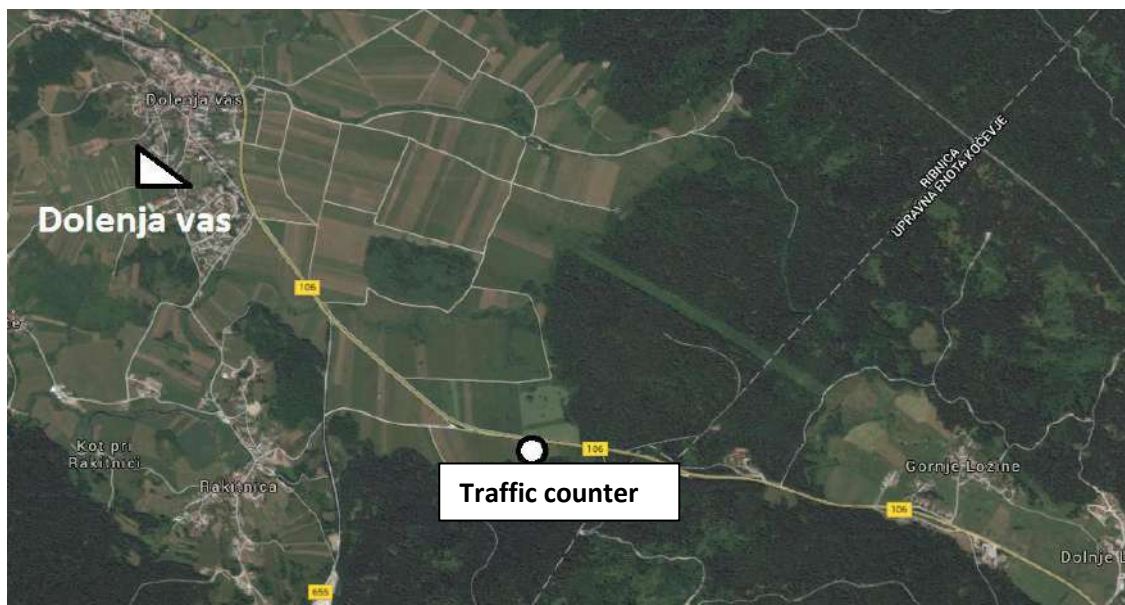
Figure 14: Map of location of traffic counter and driving direction along the main road Ljubljana – Kočevje (Jasnica) near Dolenja vas.

We have measured the speed of vehicles to allow comparison of speed of different type of vehicles before installation of dynamic traffic signs and after installation. The measuring device Viacount II or traffic counter was placed on the main road Ljubljana - Kočevje between the villages Dolenja vas and Gornje Ložine (Jasnica) in the period between 9 November 2015 (12:00) and 23 November 2015 (12:00) (before installation of dynamic traffic signs on this road section) (Grebenc, 2015). Driving direction and location of measuring device are shown on the map below (see Figures 14, 15).

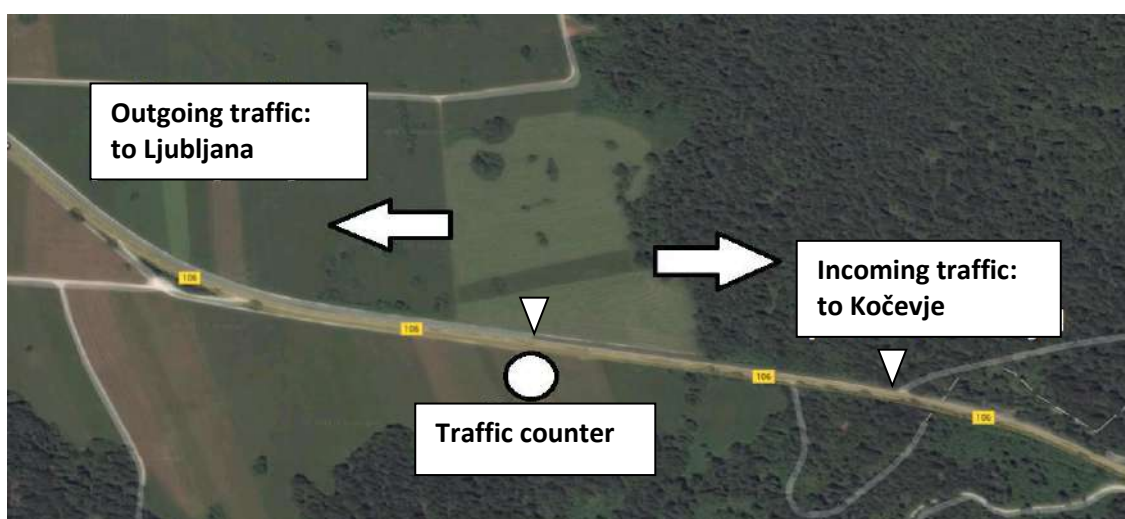
Figure 15: Location of traffic counter and direction of incoming (to Kočevje) and outgoing traffic (to Ljubljana) and location of dynamic signs (triangle), which were installed afterwards

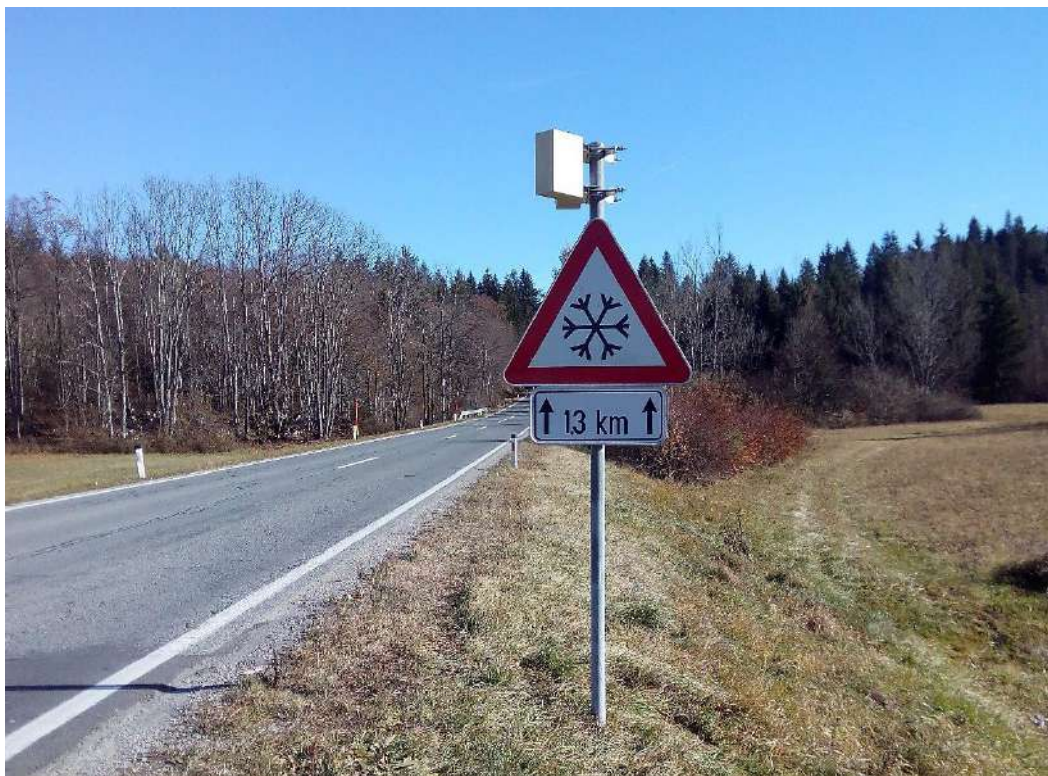
Traffic counter Viacount II is radar device for counting and classification of vehicles according to the type of vehicle. Based on the Doppler method of measurement it provides accurate and reliable measurements. The device enables the counting and measurement of the speed of vehicles in both directions, e.g. incoming and outgoing traffic. Traffic counter was placed on the pole of traffic sign at a height of 2.3 m and 1.9 m away from the road (Figure 16). Speed limit in this section of the main road is 90 km/h.

Figure 16: Traffic counter placed on the pole of traffic sign near Dolenja vas (Jasnica).

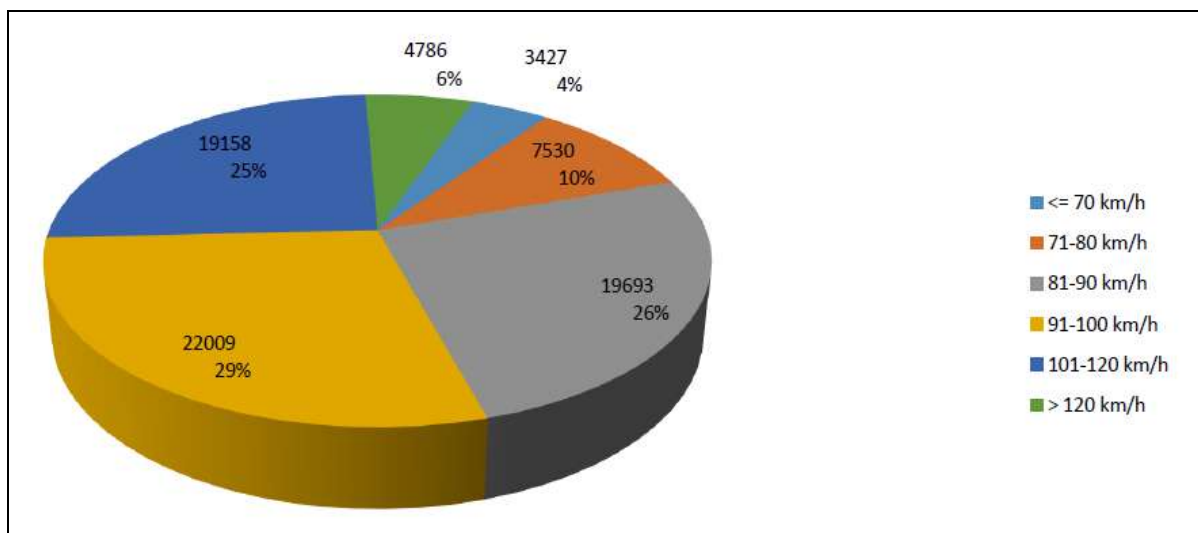
The average speed of all vehicles was 95 km/h, and maximum speed was 226 km/h. 60% of all vehicles exceeded the speed limit (90 km/h), 31% of all vehicles have speed above 100 km/h and 6% above 120 km/h (Figure 18).

Figure 17: Percentages of vehicles which were classified in different speed classes.

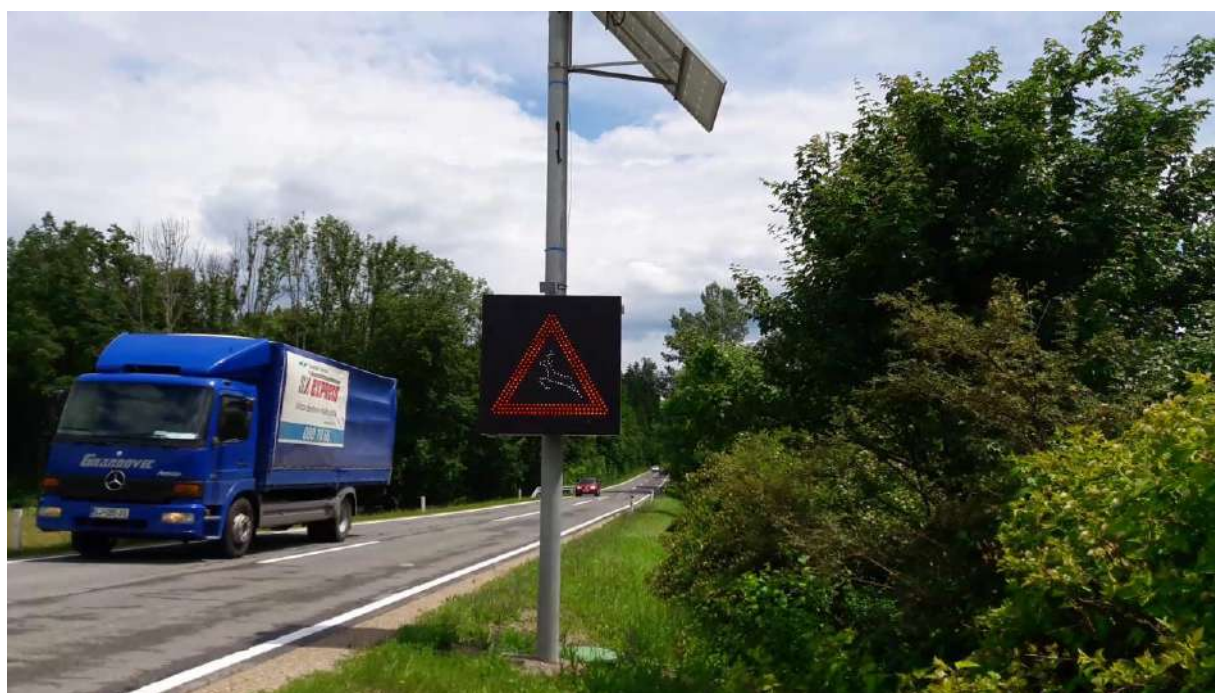
Figure 18: Active dynamic sign at Jasnica (photo: Z. Pavšek, 2016).

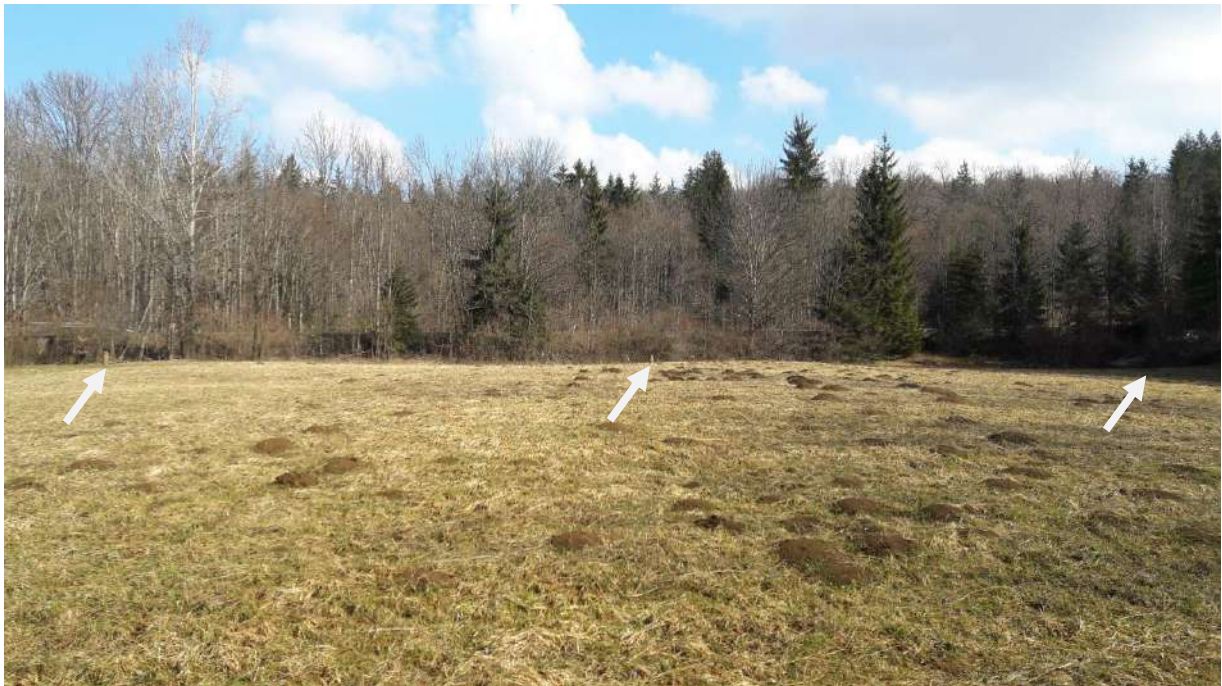
Figure 20: Meadow near main road at Jasnica, where camera was placed and frequently filmed wildlife (arrows indicate sensors in wooden stumps capable to detect large animals approaching the roadways) (foto: S. Al Sayegh Petkovšek, 2016).

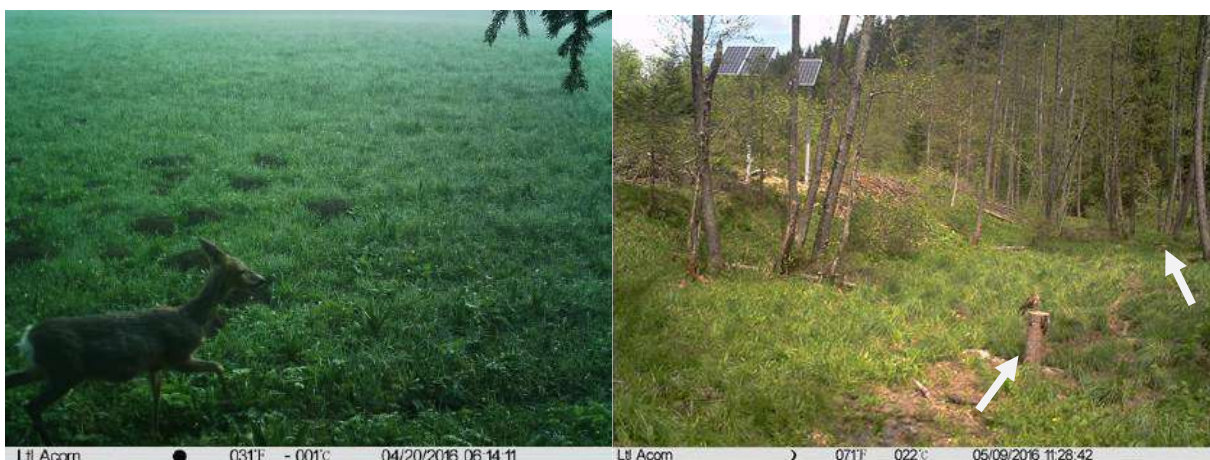
Figure 21: Images captured by the camera at Jasnica (left) and Ortnek (right) (arrows indicate sensors).

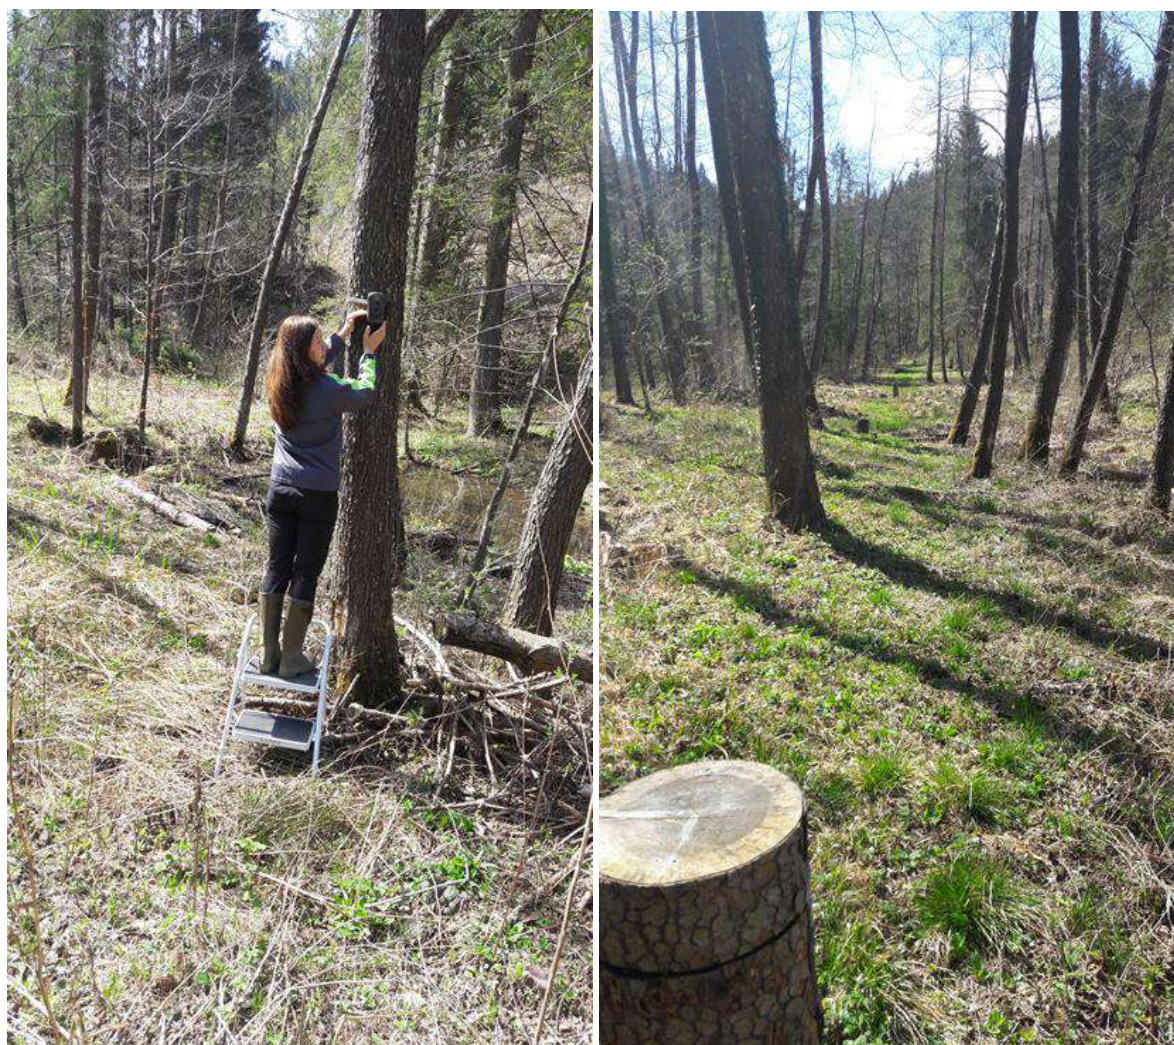
Figure 31: Installation of IR cameras at Ortnek and sensors in wooden stumps capable to detect large animals approaching the roadway (photo: Z. Pavšek, 2017).
